## SAFETY SPOT

# ON TOP FORM

THE ARRIVAL OF THE FLYING SEASON MEANS IT'S TIME FOR SOME THOROUGH CHECKS TO MAKE SURE YOUR AIRCRAFT IS ON TOP FORM

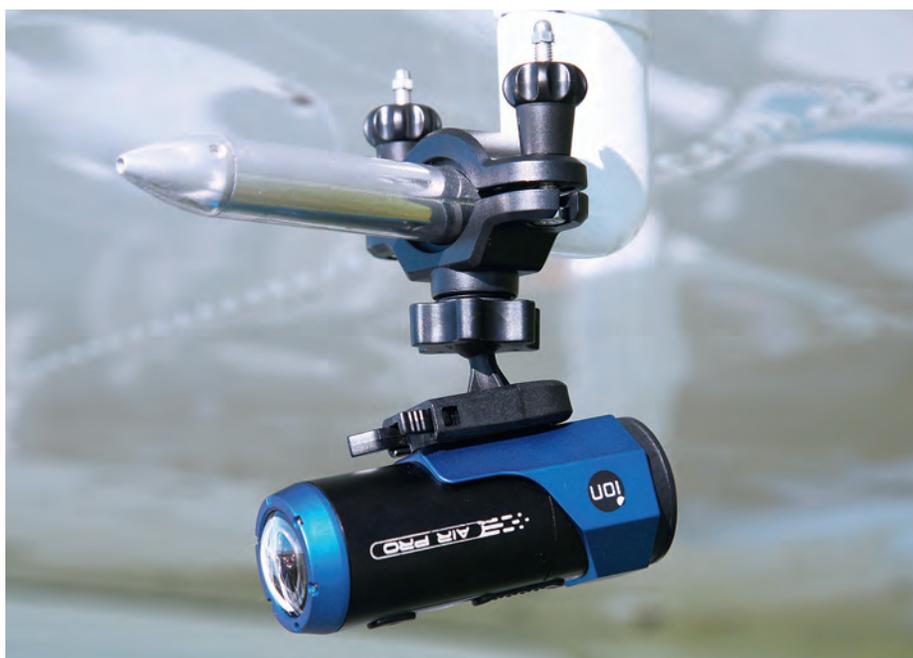
Thanks to all of you who wrote in with airworthiness concerns about the fitment of this mini-camera onto the pitot head of this un-named aircraft; many of you asked whether this fitment was covered by an LAA Modification and I can answer this easily, no. LAA Inspector, Robin Morton, summarised many of your concerns with three main comments: One, the Pitot Head and its attachment is not designed to cope with the weight and airloads imposed by the video camera. Two, the camera and its attachment bracket will cause a disturbance of the airflow at the pitot intake which may affect ASI indications and three, the installation would require a Modification. Robin, in his letter, asks, "Am I being too fussy?" Answer? Definitely not Robin... we all stay safe because we're all keeping our eyes open for gotchas like this. One thing that nobody noticed is that this is a heated pitot head... I wonder how the plastic would cope with the increased local temperatures.

need to leap back to a picture featured in Mountain Woes, the March 'Breaking the Chain' feature that discussed a horrible accident where a pilot, for reasons we will never completely know, ended up getting caught in rotor downwind of a mountain peak. Much of the event was captured on the memory chip of a cockpit-placed mini-camera; I've re-posted the picture that caused the general critique from LAA members with some comments about the airworthiness implications of such a camera 'fit'... thanks to all of you who wrote in about it, I will blame the flu for not mentioning it in last month's 'Safety Spot'.

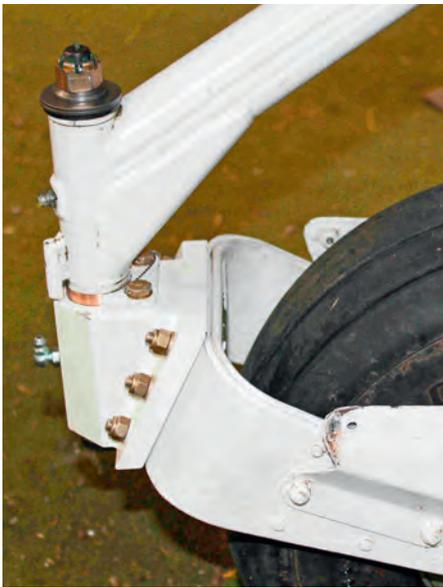
Here's a picture of the Airspeed option assembled; notice that there's a grease nipple in both the top and bottom housings. One of the lessons reinforced by the failure of the CZAW spindle assembly is that regular strip, clean and re-lubricate 'inspections' are required to ensure that there's nothing sinister going on behind the scenes; our modern age could be described as the age of 'fit and forget', especially when it's applied to motor cars... this sort of ideology doesn't work with small aeroplanes. After the initial failure checks were required on the SportCruiser fleet, a large percentage were found to have corrosion in their spindles when they were disassembled. (Photo: Derek Taylor.)

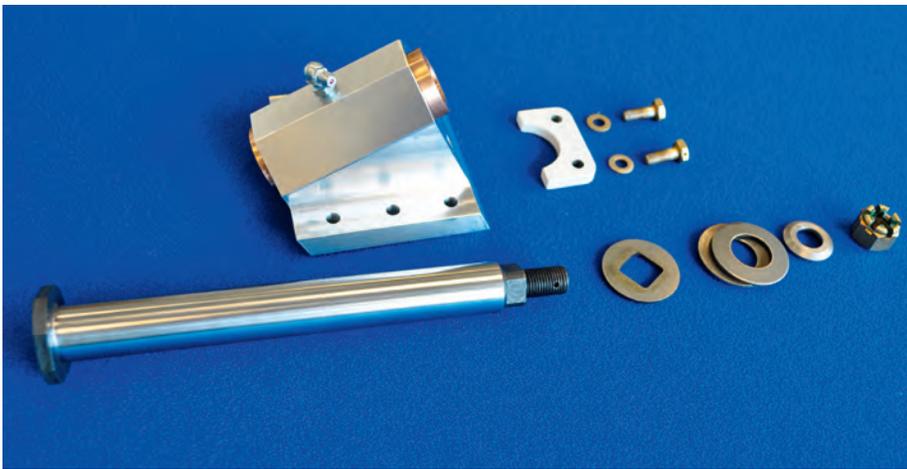
This picture shows the primary components in Airspeed Aviation's SportCruiser replacement nosewheel spindle assembly. The spindle itself is manufactured from very high strength 4340 steel which requires special heat treatment and Magnaflux (magnetic particle NDT inspection) testing before release. To prevent shimmy, the system is preloaded through Bellville washers (Photo: Malcolm McBride).

'withdraw' the CZAW nosewheel spindle assembly from service because of serious airworthiness concerns; this withdrawal has now been effected by the issuance of an LAA Airworthiness Information Leaflet (AIL) requiring a component change. At the time of writing, quite a few SportCruisers have been grounded whilst approved alternatives come on stream. CSA, the manufacturer of the ready-built (Light Sport) version of this machine is able to supply acceptable alternative 'Pipersport' nose legs, but these are relatively expensive and many owners are waiting for a cheaper, locally produced alternative.

In this case, two different LAA modifications have been approved for use on the applicant's individual aircraft and the upgrading of these modifications to Standard Modification status, needed for fleet application, is well underway, as is the batch production of the components needed. Take a look at the attached pictures, which discuss the different design solutions in a little more detail.

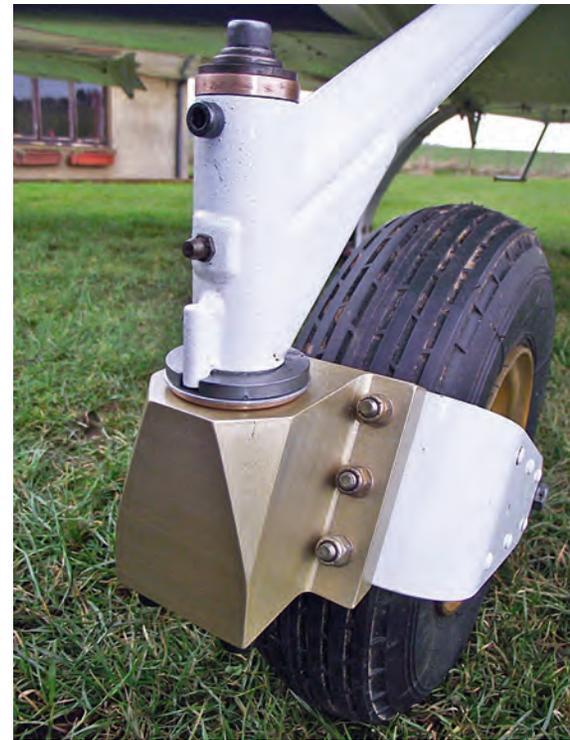
Graham Smith, the proprietor of Sprite Aviation, is the person responsible for bringing in the CZAW SportCruiser into the UK. The LAA is now treating this airframe as 'orphaned', hence the need for a home-grown design to replace the un-inspectable CZAW units. This is a picture of the Sprite replacement option which has the advantage of being cheaper than the Airspeed option but requires more work from the builder to fit... Graham intends to make drawings available to members should they wish to manufacture their own components... this option, at the time of writing, is undergoing final load tests of the attachment fitting, having been successfully test flown, before final approval. (Photo: Graham Smith)

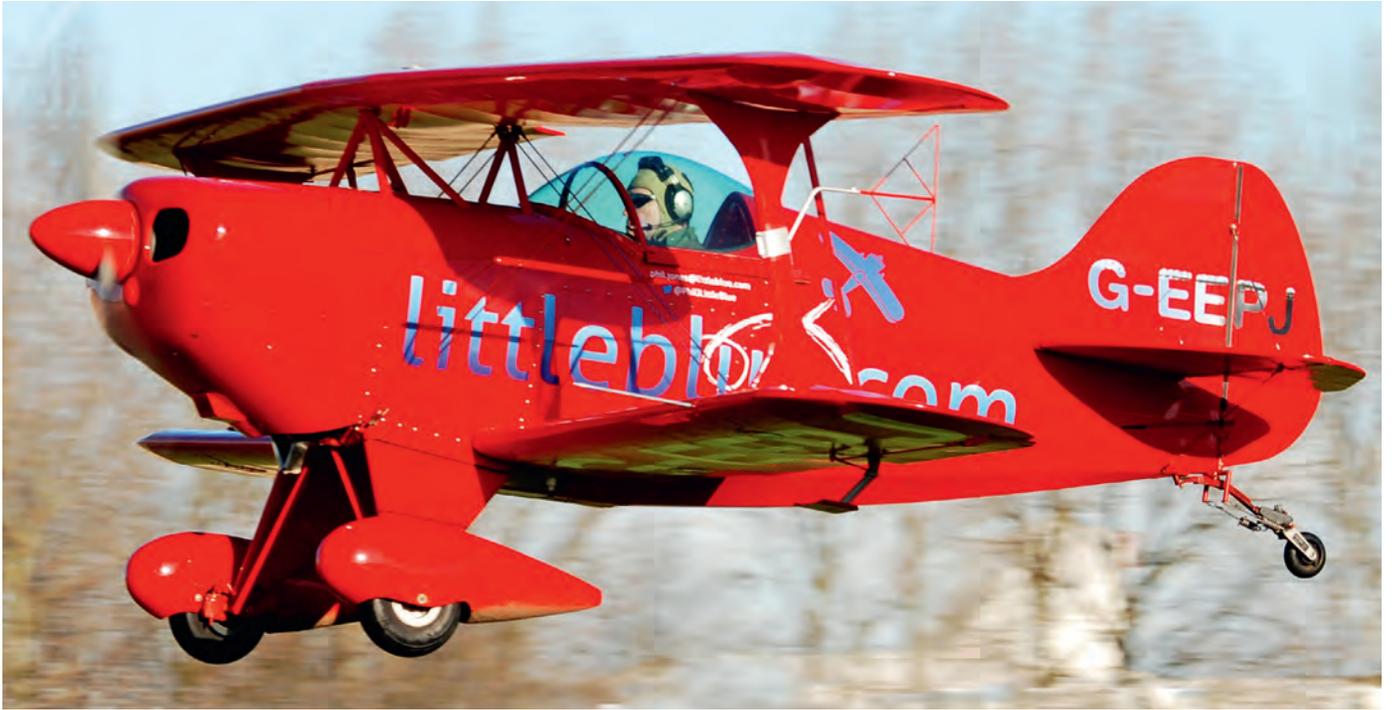
This picture makes me want to leap up and go flying... oh well, back to the keyboard! You can see that in this photograph that the spade is still attached to the left aileron. You might notice, although this takes a bit of mental gymnastics, that the spade would be very close to the ground if you were to land on one wheel. This particular machine was originally G-REAP and is an LAA homebuilt version of the type, built in 1992. (Photo: Peter Lamb)

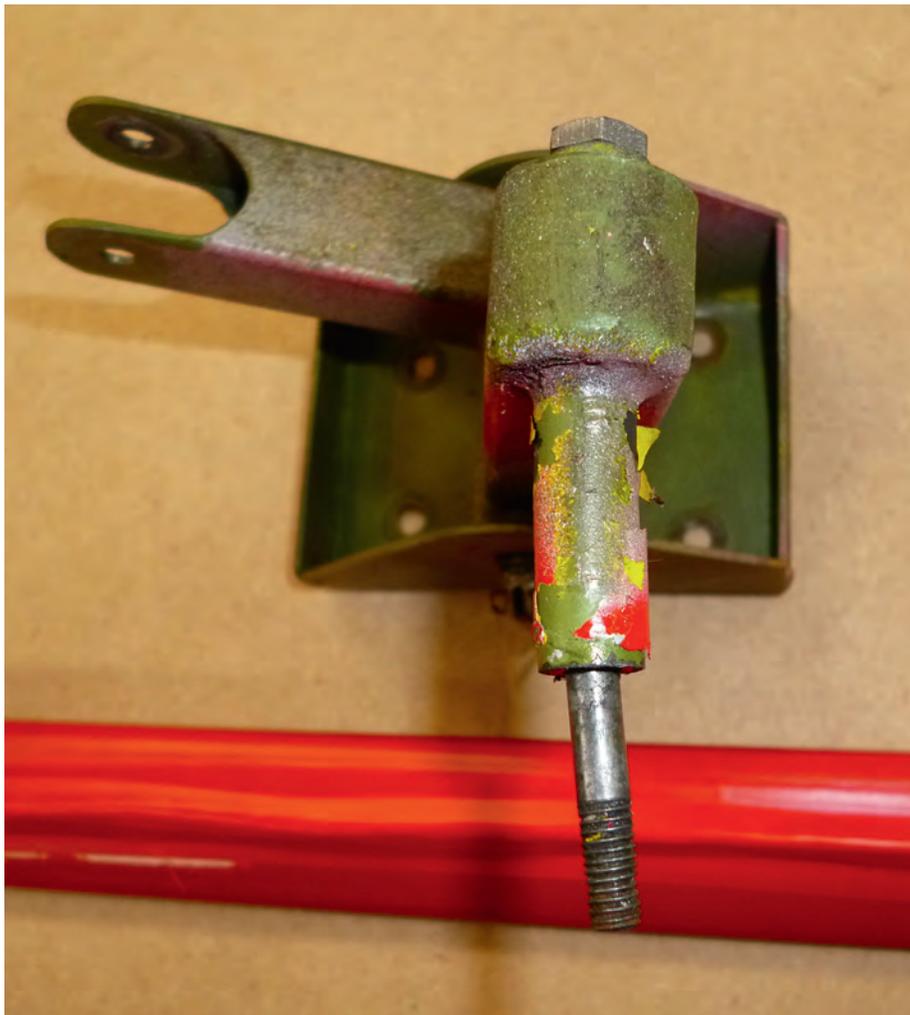
(Photo: Ian Ross)

The Pitts S1-S, as a design, is the competition aerobatic version of the S1-C. Changes include a more symmetrical wing section (the 1-C had a flat bottom wing) and ailerons on both wings. The aileron system works through push/pull rods which are connected using male-threaded Rod End Bearings, the bottom aileron acts as a master for the top aileron via a 'slave' strut. The photo above shows how impact loads resolve through a flexible structure. Notice that the threaded portion is also badly corroded which could have significantly weakened this primary control.

Ian continued, "I initially considered the incident to be quite minor and was expecting the damage to be superficial. When I got into the job it was clear that the wing structure itself was undamaged (thankfully) but this was not so for the control circuit components."

Ian listed out the damage and I've featured Ian's photos as you can see. Ian explains, "For what it's worth, the lesson I would take from this is that any impact, no matter how gentle it may have felt, can cause some quite significant damage." I certainly

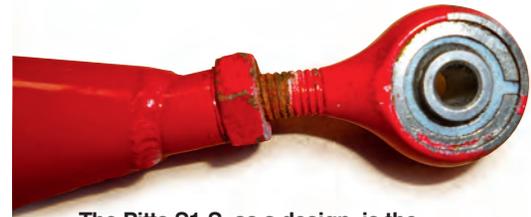
(Photo: Ian Ross)

(Below) This picture shows that the shaft of the rod end is bent. The LAA Inspector comments that the quality of the rod ends was poor (commercial items) and that the threads were cut rather than rolled. He substituted these important components with aircraft quality parts which use only rolled threads.

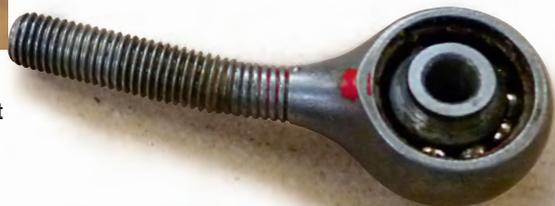
(Above) Here's another bent component from the Pitts S1-S that lost an aileron spade when accidentally landing in longer-than-expected grass; even after the slightest knock it is important to check around the whole airframe for damage. (Photo: Ian Ross)

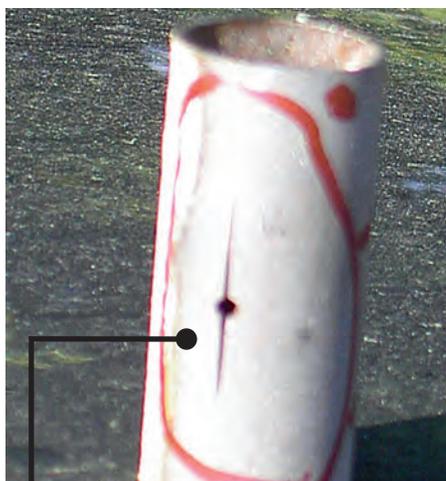
Here's another interesting picture from LAA Inspector Miles McCallum showing problems he's found in tubular airframes during inspections. This picture shows a compression crack in a top longeron (just behind the canopy) caused, to use Miles' actual words, by a hole wot should not have been there. (Photo: Miles McCallum)

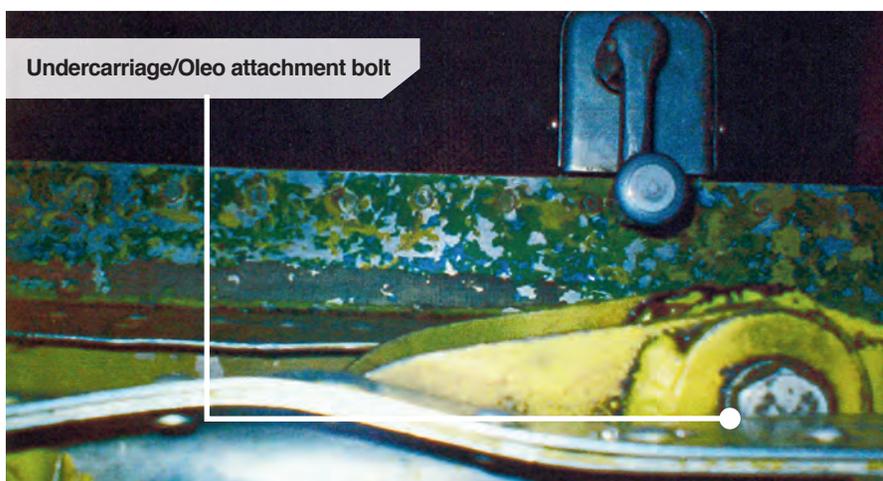
Here is a picture looking forward, if you can imagine it, from just behind the seat slightly off centre (to the left); the Oleo attachment bolt (marked) may better orientate you as I've marked it on the parts drawing overleaf. The large upwards curve in the fuselage structure to the left of it shouldn't be there and it is an indication that the structure has been overloaded at some point in the past. It wasn't spotted sooner because this area is hidden beneath carpet under the seat and the damage only came to light during a complete refurbishment of the aircraft by the owner. (Photo: Mile Griffiths)

Quite often I receive a renewal for an aircraft that has been out of Permit for some time and, unless the application includes really good worksheets describing the work done to bring the aircraft back up to flying state, I always write to the owner asking for them. This was the case with an application I received from LAA-er Mike Griffiths. Mike supplied some really good worksheets detailing very well the restoration work he'd been doing on his aircraft over the last few years, and I could see that Mike had brought the aircraft back to *concours d'élégance* quality. One thing caught my eye though that related to... well, here's the entry in Mike's worksheet: *Carpet and Trim removed for inspection (so far so good). Floor around U/C box section found to be distorted and rivets pulled.*

"Well," Mike said, "the aircraft's been undergoing a complete refurbishment and the damage to the undercarriage support was found when we lifted the carpet to service the undercarriage. I was really surprised because, after the groundloop, we had a really good look round the aircraft for damage and she looked perfect." Groundloop? "Yes, I hadn't flown for a while and needed to get myself revalidated; I've been flying the aircraft for years and know it well but, well, I let the instructor have a go at a landing and he let his feet get the better of him and we ended up groundlooping."

Mike, when he later discovered the damage, had to remove the engine and the undercarriage so that the bent frame and, as was later discovered, a complete doorpost could be replaced with off the shelf frames. It's amazing that these components are still available when you think about it! He got Steve Moon of Aviation Panels

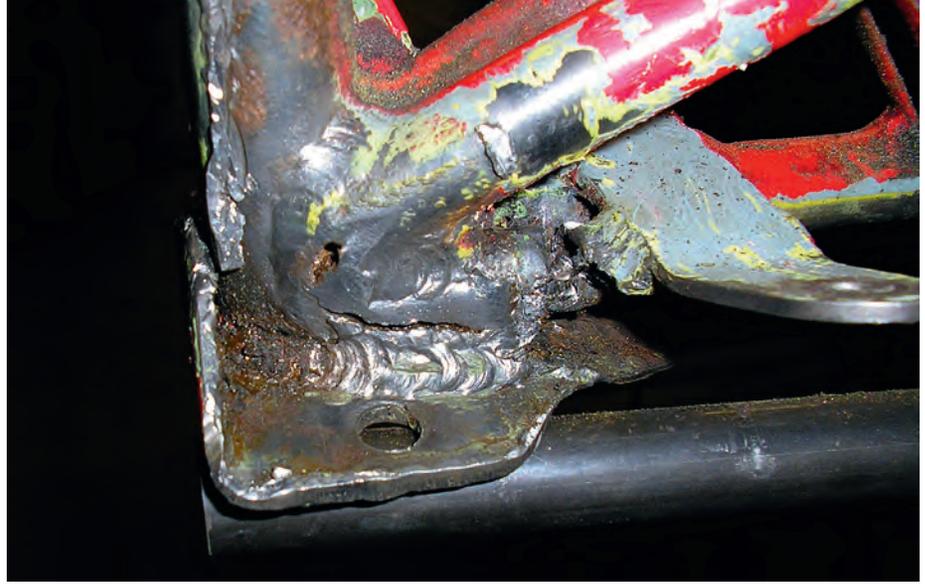
Continuing the Safety Spot theme that it's really necessary to build 'deep inspections' into your Tailored Maintenance Schedule, here's a picture of the tail area of a Starduster recently presented to LAA-er repairer Paul Grellier at Airweld; you can see that the tailwheel attachment plate has nearly completely separated from the fuselage rear longerons. You will note the failure along the edge of the weld and areas of corrosion, you may not spot that the tailplane lower brace wire attachment has been fitted to the top of the bottom longeron and therefore not to drawing; this means that the tailplane's security is completely reliant on a welded joint in tension; naturally, this was put back to standard before being released to service. (Photo: Paul Grellier)
