NO SPINNER HELPED THIS SPOT

AN EXCELLENT SPOT DURING A WALKROUND PREVENTS AN IN-FLIGHT DISASTER – AND A LACK OF BASIC FITTING SKILLS IS BEHIND OTHER PROBLEMS

SAFETY SPOT

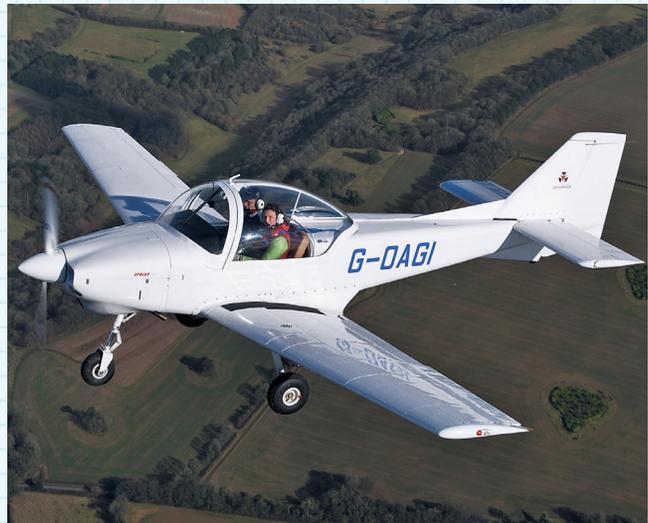
The very photogenic Sprint and, personally, I think that this is a smashing looking aircraft. The design originated as the Trago-Mills SAH 1 and there are four examples still flying in the UK. This is the only LAA example, the FLS Sprint 160. (Photo: Chris Burleigh)
