With Malcolm McBride
Airworthiness Engineer

SAFETY SPOT

SPORTCRUISER: NOSEWHEEL FORKS

JABIRU UL430: MAIN UNDERCARRIAGE FAILURE

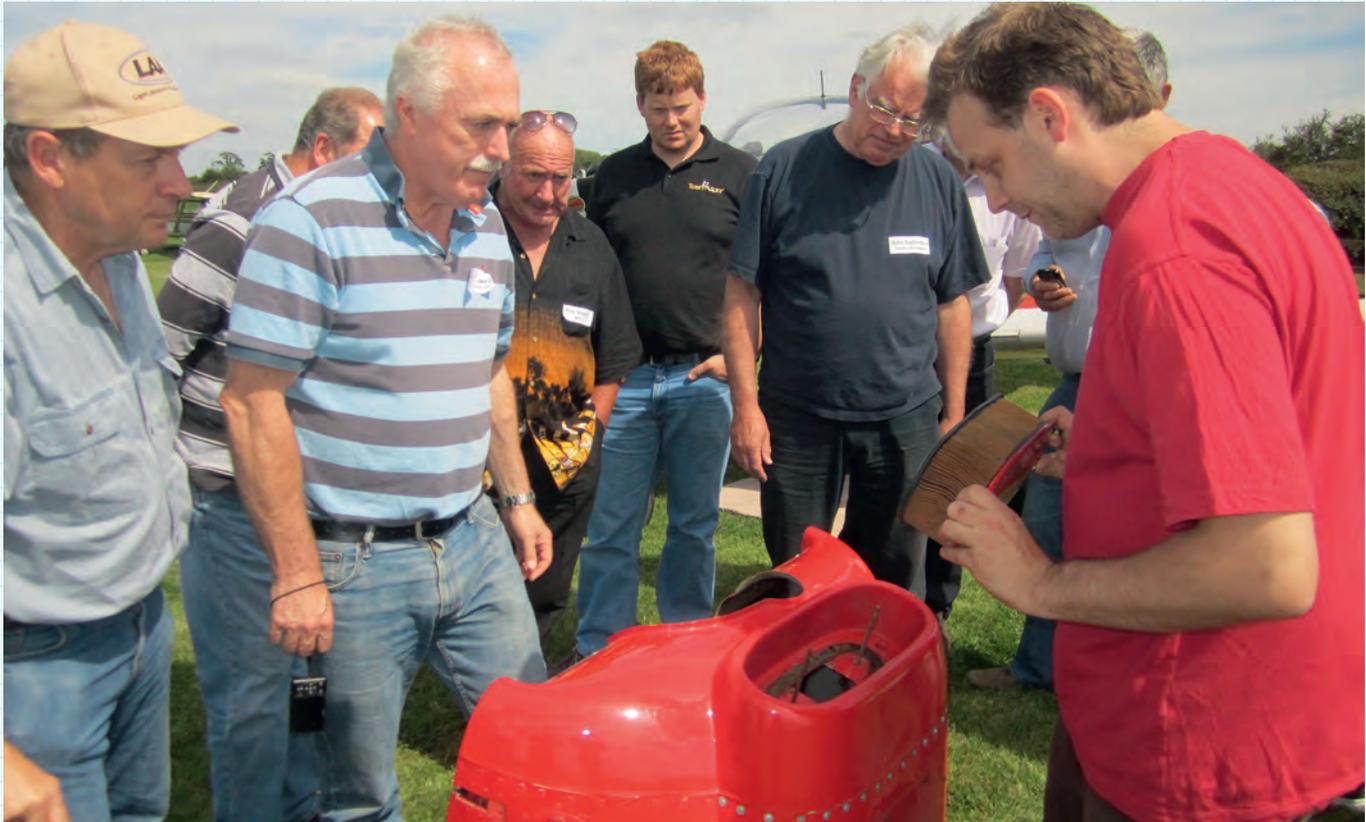
Above: LAA Inspector and Bulldog course instructor David Jones of Airspeed Aviation (Derby), explaining the importance of checking the seals on air filters to ensure that debris cannot be ingested into the engine. From left to right: Robin Johnson, David Ross (hiding), Fran Sandwell, Roy Sears, Stephen Woods, John Robertson. (Photo: Ken Cragie)

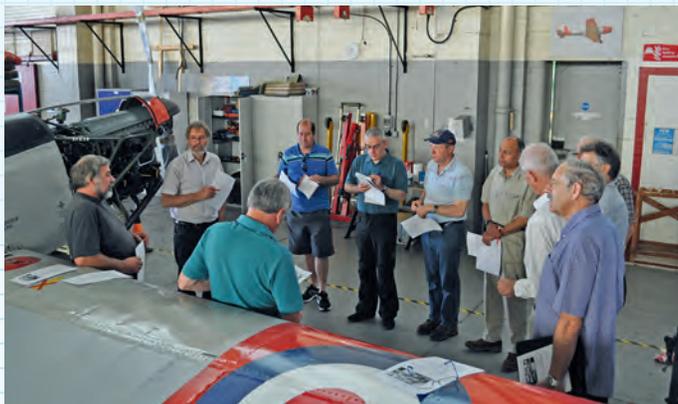
Left: the Chipmunk course, held in the famous main hangar at Bicester Aerodrome in July this year, was so well attended that the course had to be split into two groups, one in the classroom and one at the aircraft. The Chipmunk featuring centre stage was undergoing a major overhaul and it was extremely useful for the course attendees to take a close look deep into the complex structure of this fairly new addition to the LAA fleet. From wing-root clockwise: course instructor Alan Turney, Tim Rayner, Andy Harmer, Stuart Allen, Robin Johnson, Rudy Floate, John Giddins, Mike Thomas and, with his back to the camera, course instructor Dennis Neville. (Photo: Malcolm McBride)

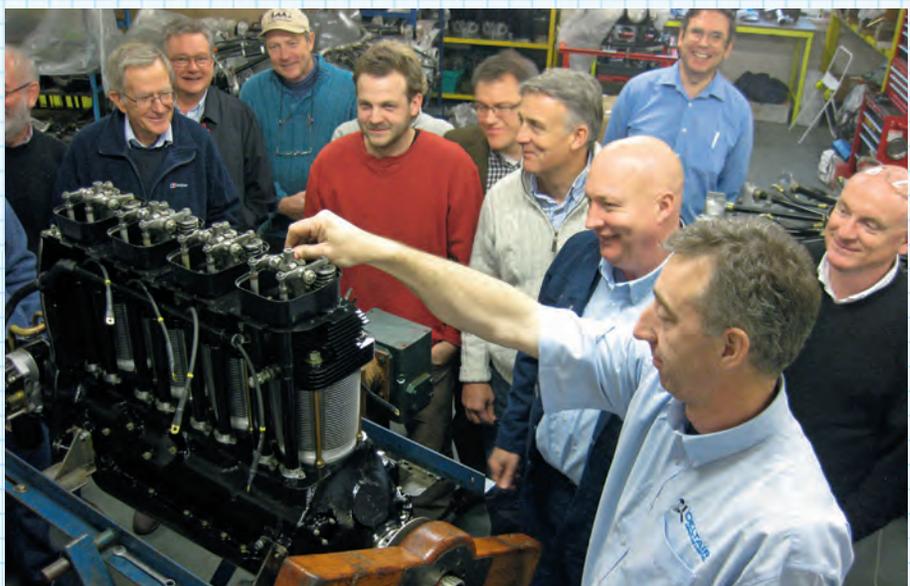
Right: Delta Airmotive's Chris Adams and Peter House explain the timing procedure on a Gipsy Major engine that was actually undergoing a complete overhaul at their brilliant facility in Waterlooville, Hampshire. This course was so popular that it had to be held twice! From top left to right: Neil Geddes, Kevin Crumplin, LAA Director Barry Plumb, Robin Johnson, David Jones, Iain Noakes, Richard Kimberly, LAA Chief Engineer Francis Donaldson, Instructor Peter House, Keith Leyland, Chris Adams. (Photo: Malcolm McBride)
