STOPPING TROUBLE ON THE SPOT

Good inspection practices, typical schedules and potential problems well spotted

SAFETY SPOT

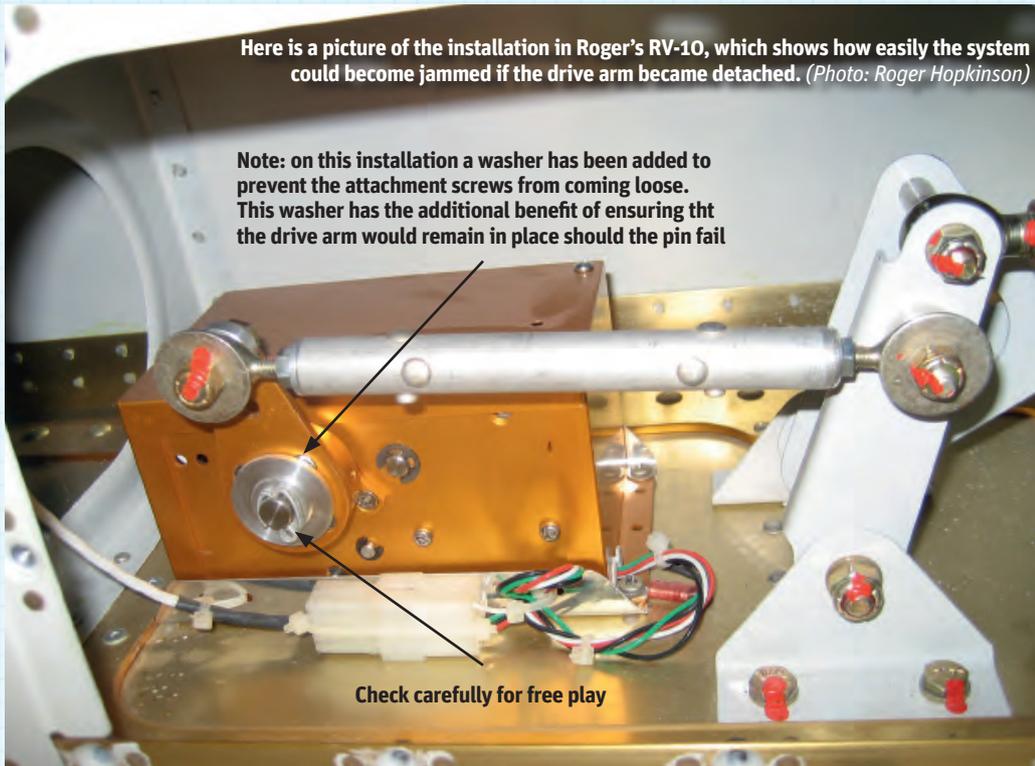
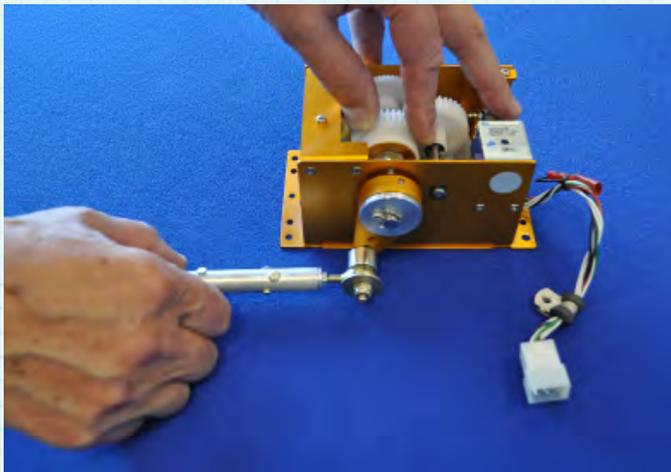
This is an atmospheric shot, more akin to a certain car manufacturer I used to work for. Roger explained that the autopilot fitted to his RV-10 is the Trio EZ system, which includes both heading and altitude-hold functions. The safety features include warnings for minimum and maximum airspeed and a g force limit. Each servo has a clutch, which can be overcome by the pilot should all else fail. It is a testament to modern electronics that this set-up, when coupled to a Garmin or Bendix/King GPS, will fly the aircraft accurately along a pre-determined track at a pre-set altitude. One thing that this unit won't do is adjust the power from the engine... yet. Sounds like armchair flying to me! (Photo: Roger Hopkinson)

When the dust settled and I had disconnected my personal autopilot, Roger explained why the autopilot servo sat on the bench and wasn't in his airframe. He had discovered that the drive pin that secured the operating arm to the autopilot's drive shaft had nearly fallen out and he was very worried by the alarming amount of wear between this shaft and the operating arm. In the first instance, the failure of this connection would mean that drive would be lost from the autopilot - worrisome but probably not a desperate problem as a flight could be hand-flown to destination. The real danger as

far as Roger was concerned was that the arm could wind itself off the shaft and, because it's mechanically connected via a drive rod to the primary control drives, in this case the elevator push rod, under some circumstances the elevator control could become jammed or at very least cause a control restriction. Not a pleasant thought.

The other worrying aspect of this incident is the wear discovered between the shaft and the arm itself. This is not so easy to check, for as the arm and shaft are free to rotate when the autopilot is disengaged. We were able to check this play with the servo's cover removed by fixing the drive cogs; it might be possible to check for play by engaging the autopilot and getting an assistant to move the primary control while you look for any movement in the linkages.

Roger, a professional engineer himself, had been worried about the possibility of this arm coming loose because the attaching screws could unwind. He came up with a very simple idea when he built the aircraft to prevent this from happening, using a home-turned aluminium washer held in place on the shaft using a split pin. You will see when you view the photographs, that this would have the additional benefit of preventing the operating arm from falling off the shaft if the pin should fall out.

At the time of writing, we're still waiting for the manufacturer's recommendations but, in the meantime, we've written to all the owners who have specifically applied for a mod to fit this autopilot system to their aircraft. In the letter we've made owners aware that there may be a problem beginning to develop with this component. If you own a Trio autopilot on your aircraft and you haven't received a letter may I ask you to let us know here at Engineering HQ that you're not on our list. That way, when we do have specific inspection advice, we can send it to you.
