SAFETY SPOT

HIDDEN DEPTHS

SOME PROBLEMS ARE BURIED DEEPER THAN OTHERS, IT'S IMPORTANT TO CONSIDER THIS IN YOUR TAILORED MAINTENANCE SCHEDULE

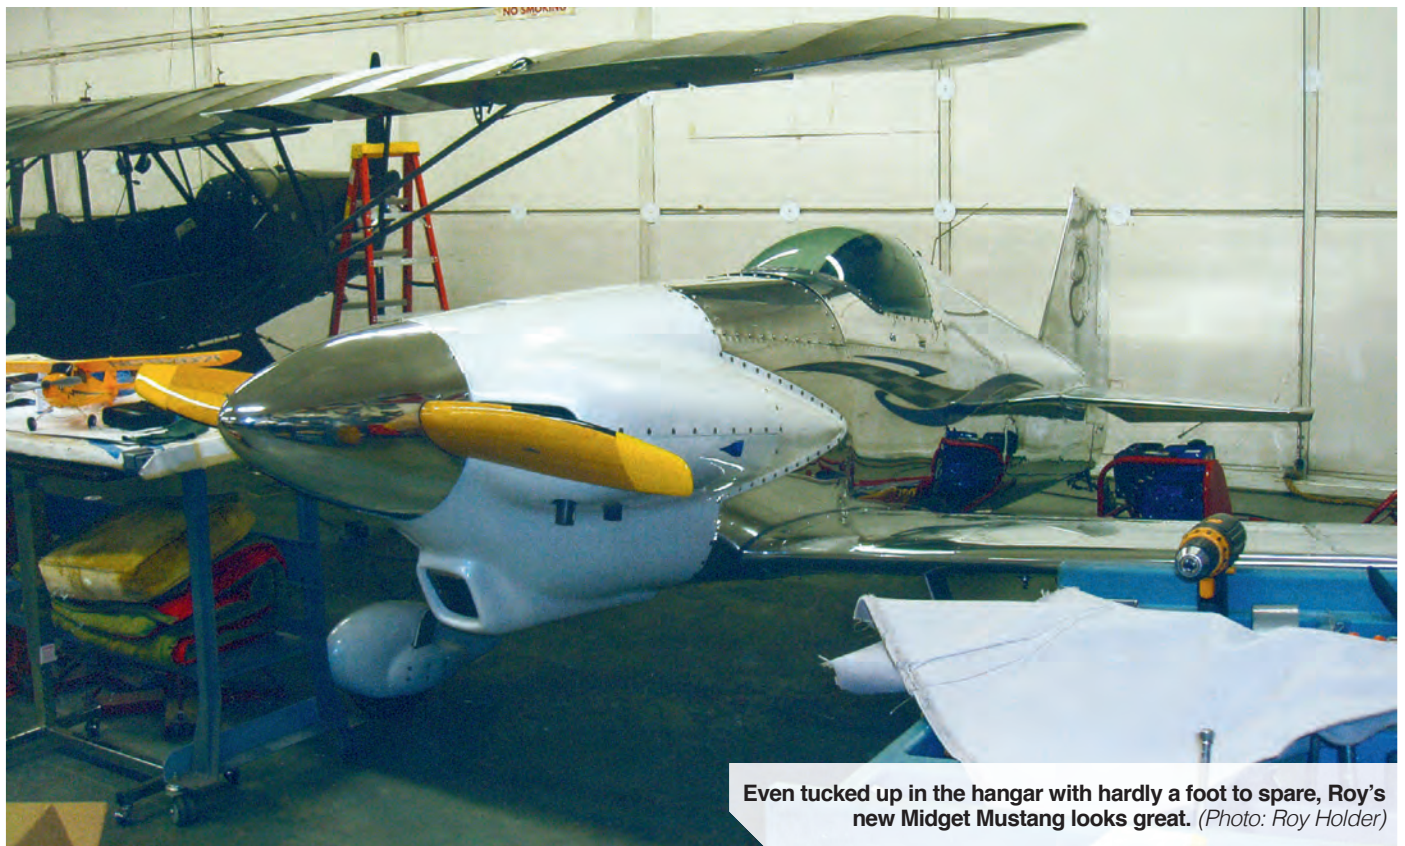
Even tucked up in the hangar with hardly a foot to spare, Roy's new Midget Mustang looks great. (Photo: Roy Holder)

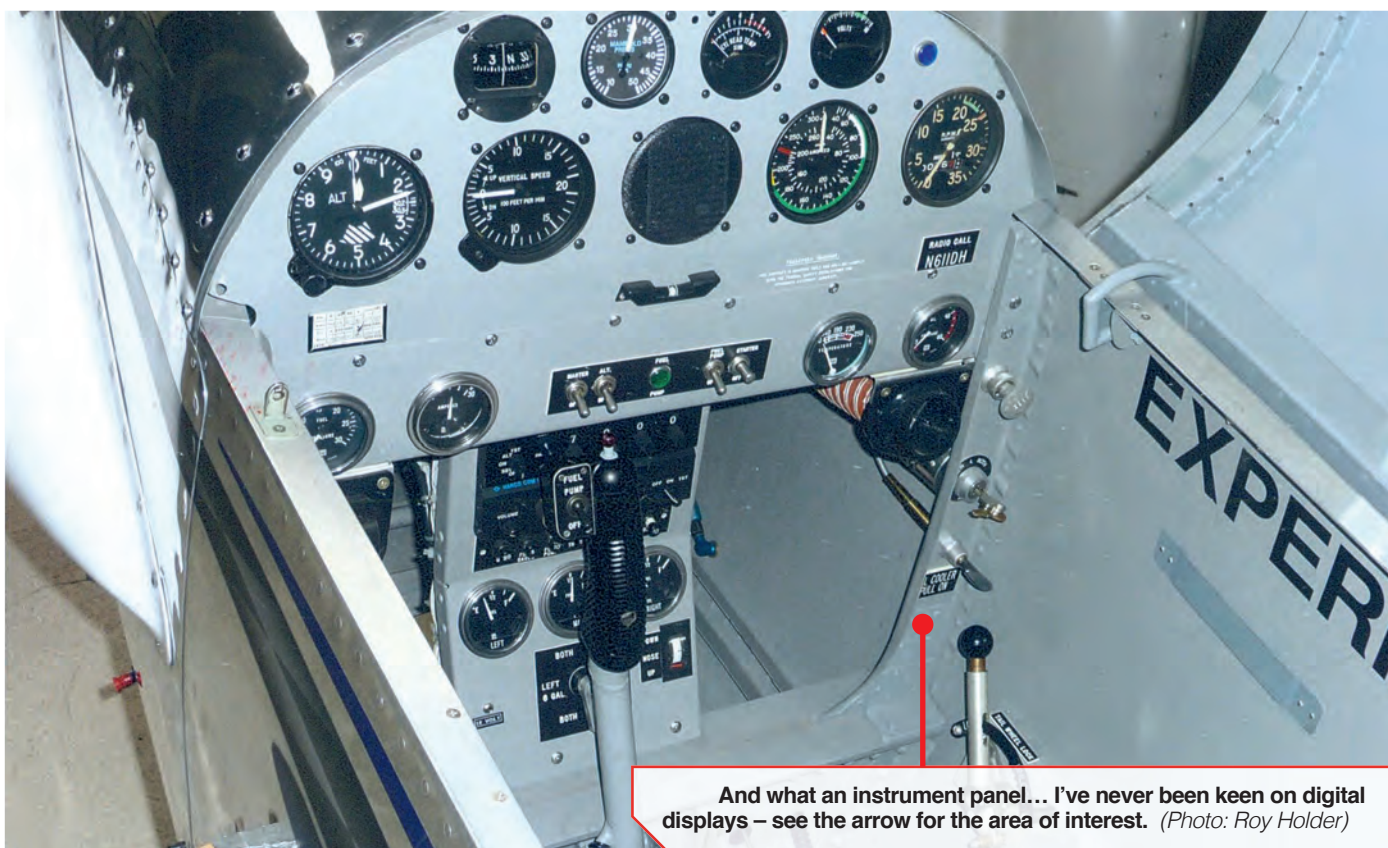
And what an instrument panel... I've never been keen on digital displays – see the arrow for the area of interest. (Photo: Roy Holder)

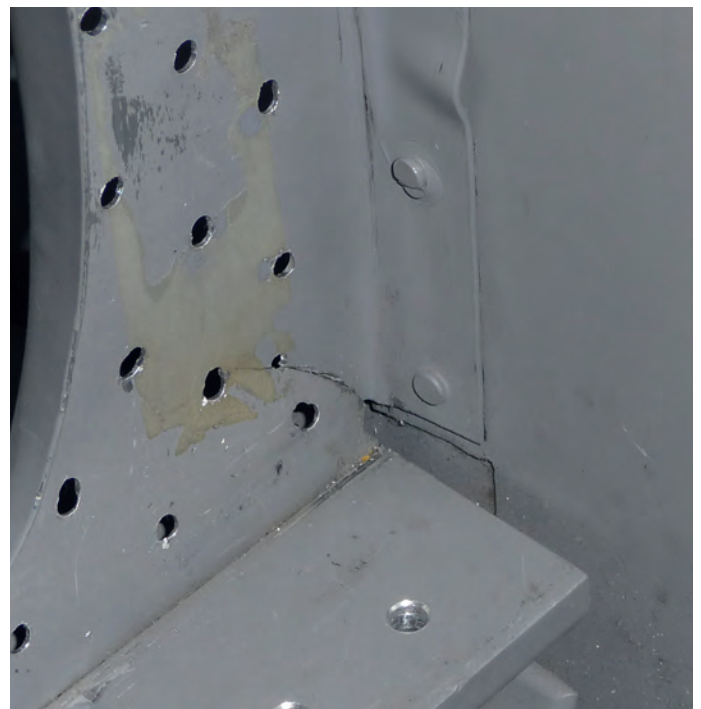
When Roy drilled out the rivets he was aghast to find that the frame had cracked through; note the stop drill at the end of the crack – clearly the engineer who did this was rather behind the common sense curve. (Photo: Roy Holder)
