A GOOD PRE-FLIGHT ROUTINE

Another year and we've made it through – in the final Safety Spot of 2013, we look at the importance of a thorough pre-flight routine

DENNEY KITFOX II – UNDERCARRIAGE FAILURE

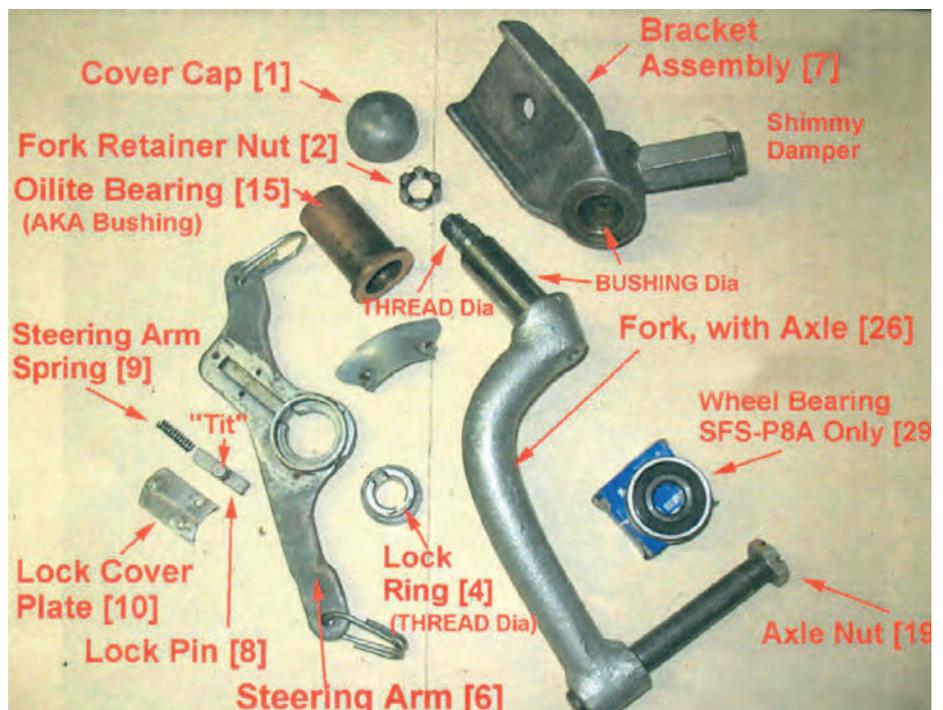
Above is a picture of a dismantled Maule tailwheel assembly. Notice that the steering arm is connected to the fork assembly through a spring-loaded lock pin; this allows the pilot to perform gentle turns using rudder and tight turns using differential brake. A good shove on the side of the fuselage will (or should) unlatch this type of tailwheel which allows ground personnel to push the aircraft backwards. (Photo: Drew Fidoe)
