HOT AND BOTHERED

AERONCA 7AC CHAMPION PROPELLER FAILURE

AVIONS FAIREY TIPSY NIPPER WING FAILURE

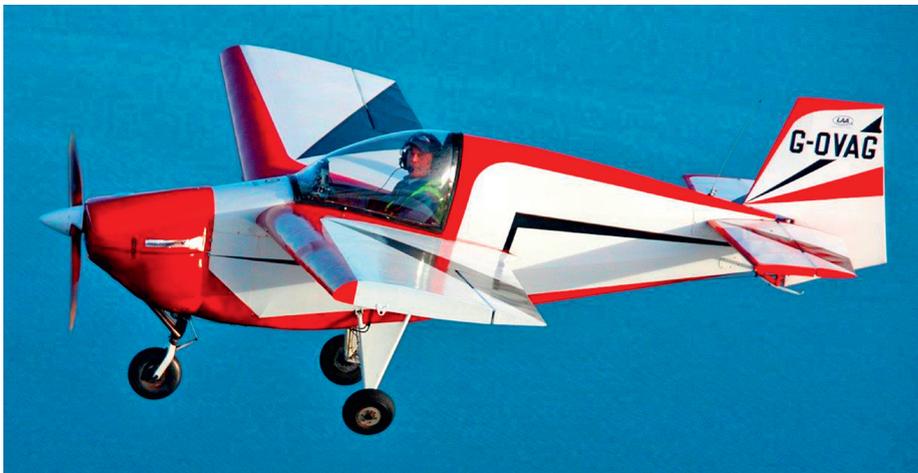
Here's a picture of the actual aircraft in happier times. This image was taken on the way back from the Isle of Bute on a beautiful day over the Clyde estuary. The Nipper fuselage comprises a steel-welded frame and the one-piece wing is made from wood; both structures are fabric covered. Note that this example has an all-flying one-piece fin/rudder – others had a more conventional fixed fin and movable rudder.

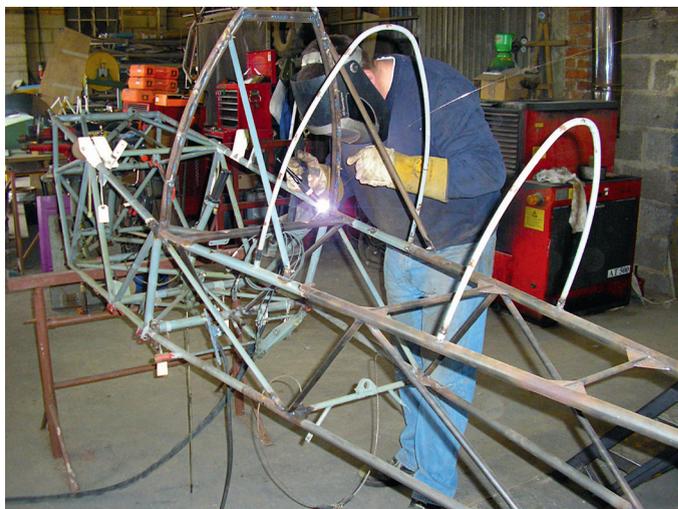
Airweld, the Hampshire based aircraft welding company, hope to soon be able to offer Nipper kits into the marketplace... being honest, I could be tempted. This picture shows a welder putting the final touches to a Nipper fuselage.

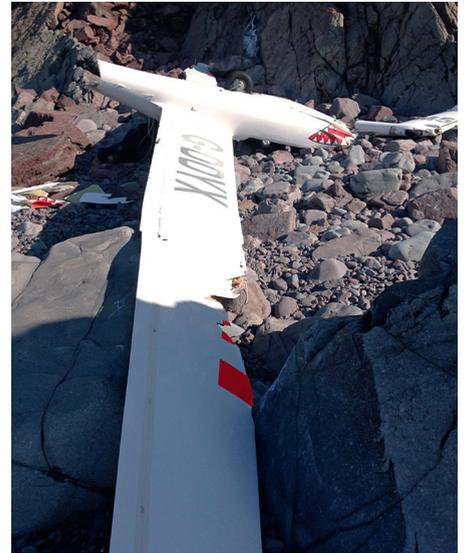
LAA Inspector and glider rebuild aficionado Roger Targett sent me a picture of a tab he'd found on the beach in Devon, I didn't recognise the tab but was curious as to why Roger was on a beach. "Are you on holiday?" I asked. "No," he exclaimed, "I'm self employed, what's a holiday?" Roger explained that he'd been brought in by an insurance company to remove a Schleicher ASW 20 that had beached itself after ditching – in the end they had to use a helicopter... but, during the exercise he'd found the mystery tab (*see below*). Incidentally, I read the pilot's report into the incident... he managed to swim to shore after ditching. The pilot reported that his tail hit the water first and he flipped over and went in to the water upside down. He allowed the cabin to fill with water before he hit the release button. This allowed him to float to the surface. The pilot had a lifejacket. (Photo: Roger Targett)

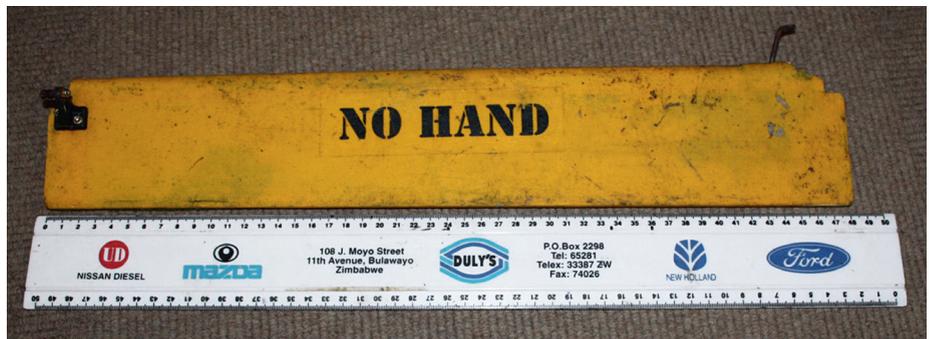
Here's the mystery trim tab... anybody recognise it? My guess is that it comes from an UAV, but that's just my guess – you may know differently! (Photo: Roger Targett)
