Annabelle Burroughes has enjoyed the delights of her Jungsmann for eight years but a tricky crosswind caught her out. *Light Aviation* will be following her rebuild of the aeroplane over the coming months as she sets out to have it flying again by next spring.

JUNGMANN REBUILD

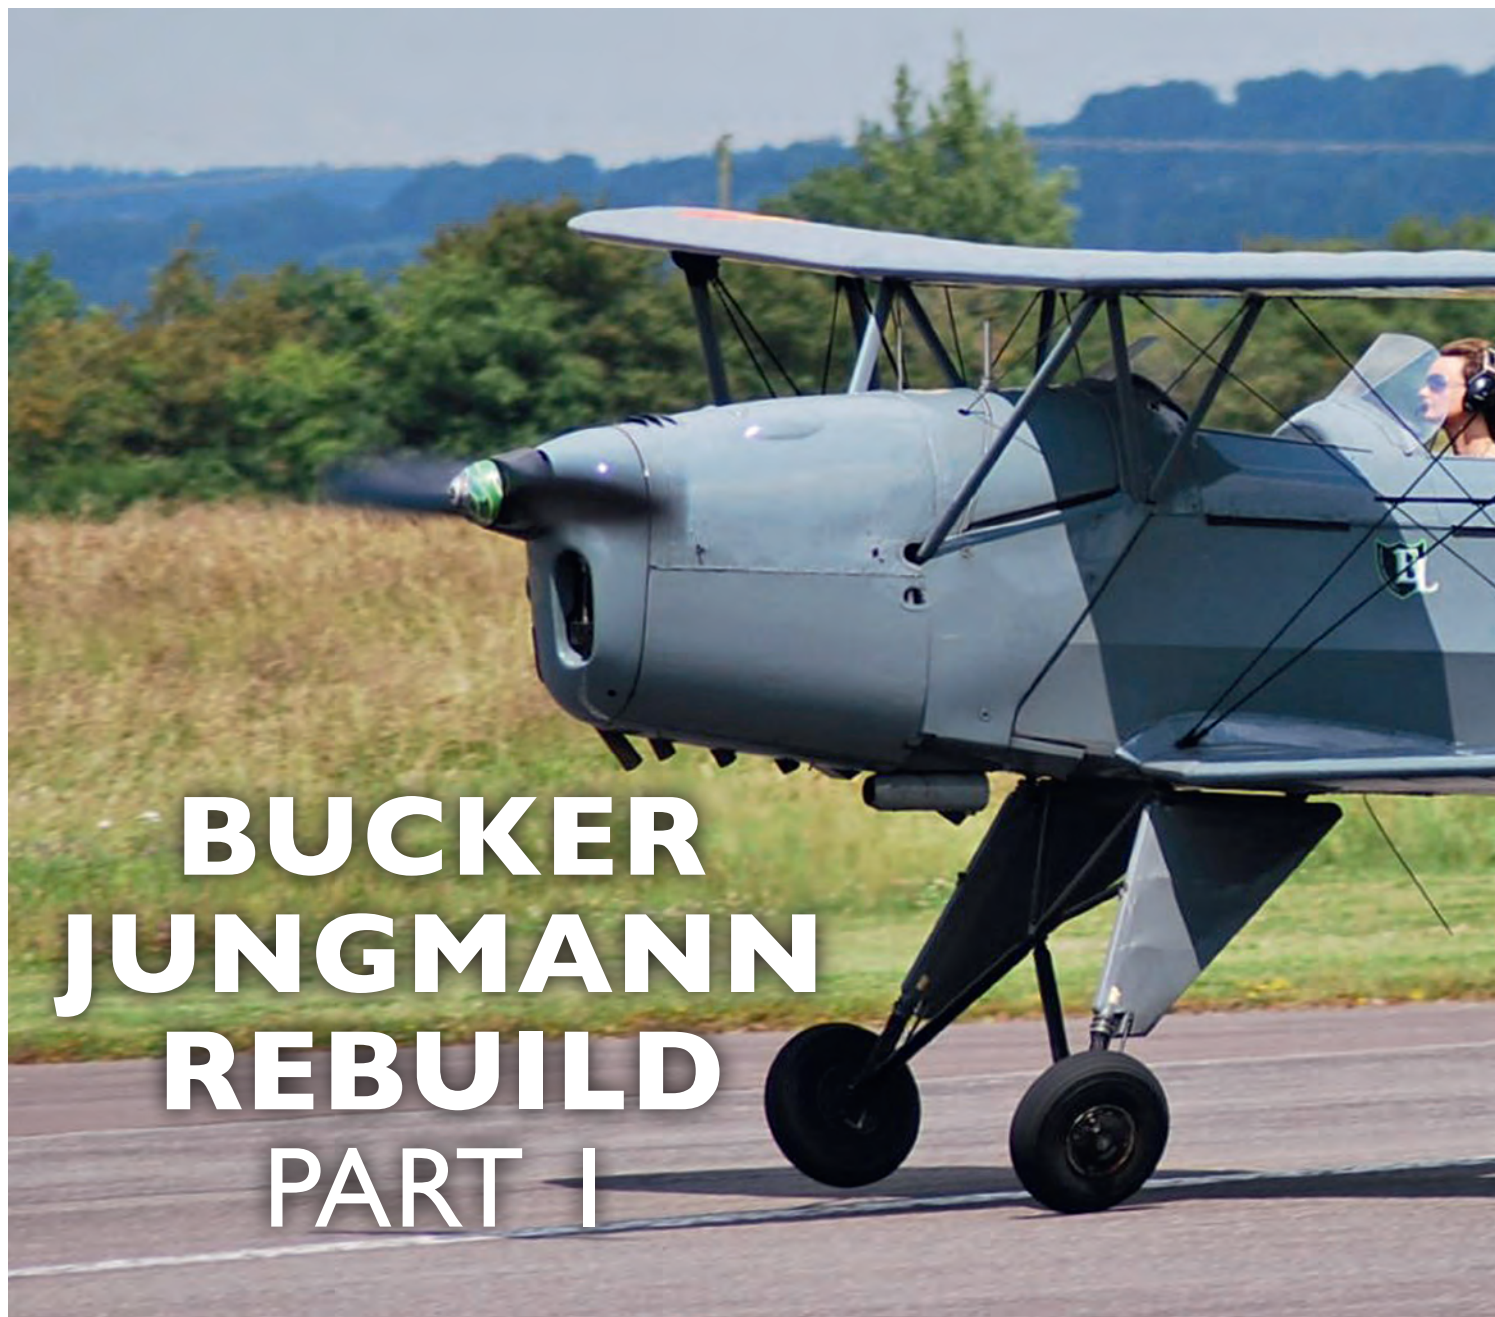
Justin walked around and around deep in thought. The problem was the right undercarriage had bent under the aeroplane and the rear of the leg fairing was through the floor. The worry was that if we just pulled the tail down, the right leg might collapse completely and damage her wing even more.
