SAFETY SPOT

WE LIVE AND LEARN... SOMETIMES

SILENCE TWISTER – TAILPLANE ATTACHMENT FAILURE

AUSTER J5G – IN-FLIGHT AILERON CABLE FAILURE

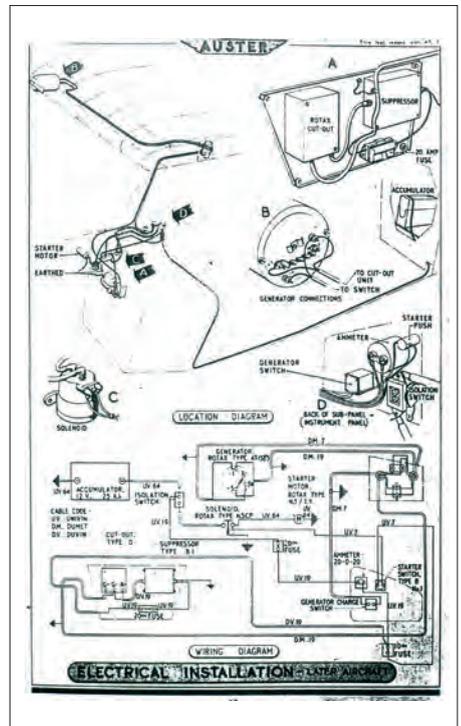
This picture shows the general arrangement of the installation and wiring for the Auster with the optional generator and electrical starter. This generator shown is the early type where, as you can see, the output terminals emanate from the rear of the casing. (Photo: Auster Aircraft)

When re-installing the generator, always ensure that it is not pushed too far into the wing since its mounting will foul the aileron cables and possibly cause shorting, with serious results.

Following the landing we began to investigate what had gone wrong. We found that cable had broken behind the wind driven generator mounted on the leading-edge of the wing. The generator is mounted in the wing by the means of a flat steel band that clamps round the body of the generator. We noticed that the generator was ever-so-slightly loose! We checked and the clamp and bolts were however, still tight. The generator should have a cork gasket round the body for the clamp to bite down tight and hold it firm, but unless you removed the generator there was no way of seeing if the cork gasket was there or not; there were only a few small bits left. We guessed that either it had degraded with age or hadn't been there at all!

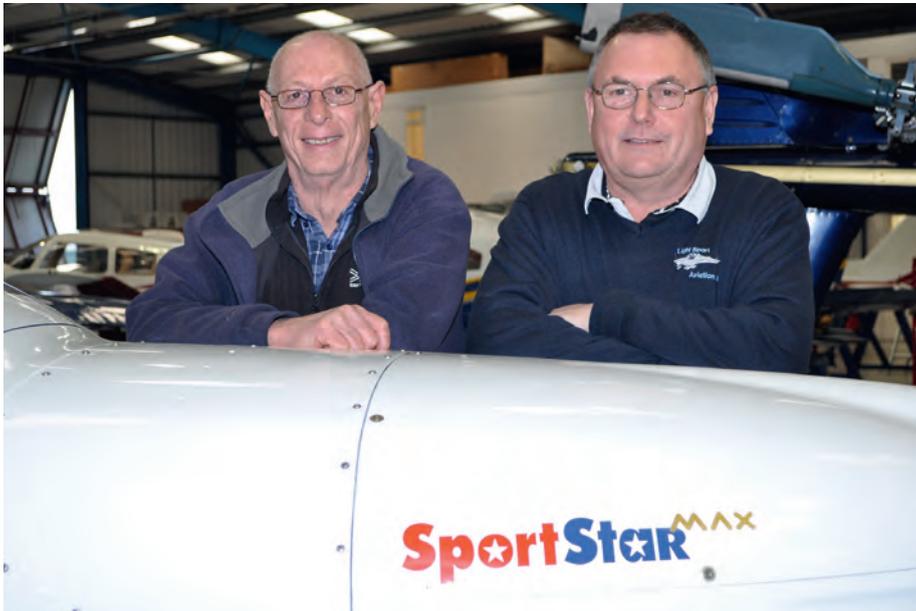
Here's a picture of the new EV-97 agents Edmund Otun and Steve Pike who together make up Light Sport Aviation Ltd. I took this shot during a visit a week or so ago when I took the opportunity to visit their brilliant facility at Booker Aerodrome. They are seen leaning on the new SportStar Max, the latest Light Sports category machine which, if interest is big enough, they hope to 'kit'. Good luck to Edmund and Steve in their new venture.
