With Malcolm McBride
Airworthiness Engineer

FORCED LANDINGS & DEPARTING DOORS

Piper PA18 Super Cub – In-flight Engine Failure

Europa XS – Door Torn off In Flight

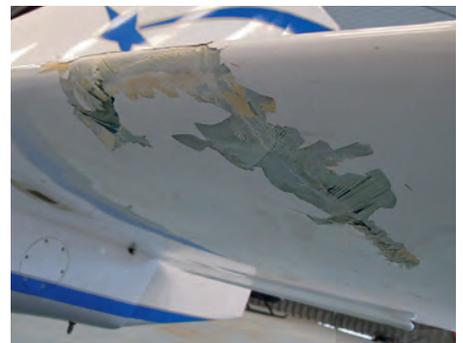
Here's a picture of the failed hinge on the Europa that's lost its door during a check flight. You can see that the aerodynamic loads trying to pull the door open are substantial enough to break the fibreglass structure. (Photo: Stephen Tucker)

This picture, showing the rear shoot bolt guide, shows clearly from the witness/wear mark left behind that when the aircraft took off the rear shoot bolt wasn't engaged. The fact that the door wasn't closed properly wouldn't necessarily be noticed by the crew until the airspeed passed a critical point, in this case, 110kt. (Photo: Stephen Tucker)
