With Malcolm McBride  
Airworthiness Engineer

# PROP SWINGING, ENGINE FAILURES AND CORROSION

Advice and anecdotes including hand-swinging, 14 engine failures and corroded and malformed cable swages, to a split propeller blade and rodent-damage behind an instrument panel

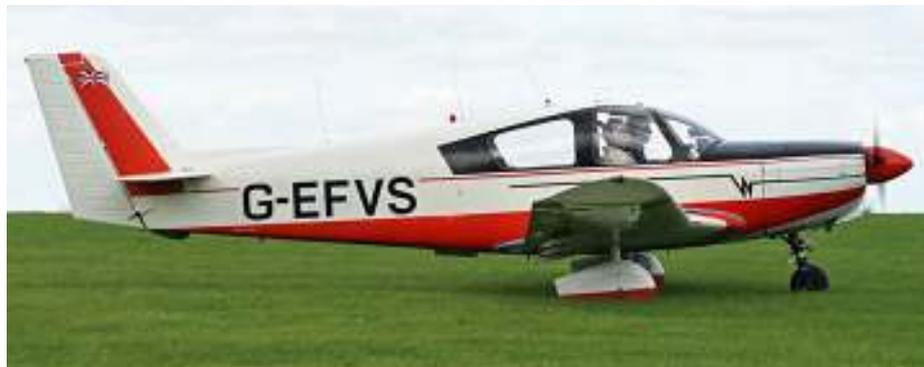
This picture shows David's Wassmer WA-52 aircraft; the LAA has three of these 1960's fibreglass machines in its fleet, two of them flying with current Permits (both in the south) and one machine under restoration in Scotland. About 150 of these four-seaters were built by Societe Wassmer during the production run. (Photo: Neil Bassett, G-INFO)

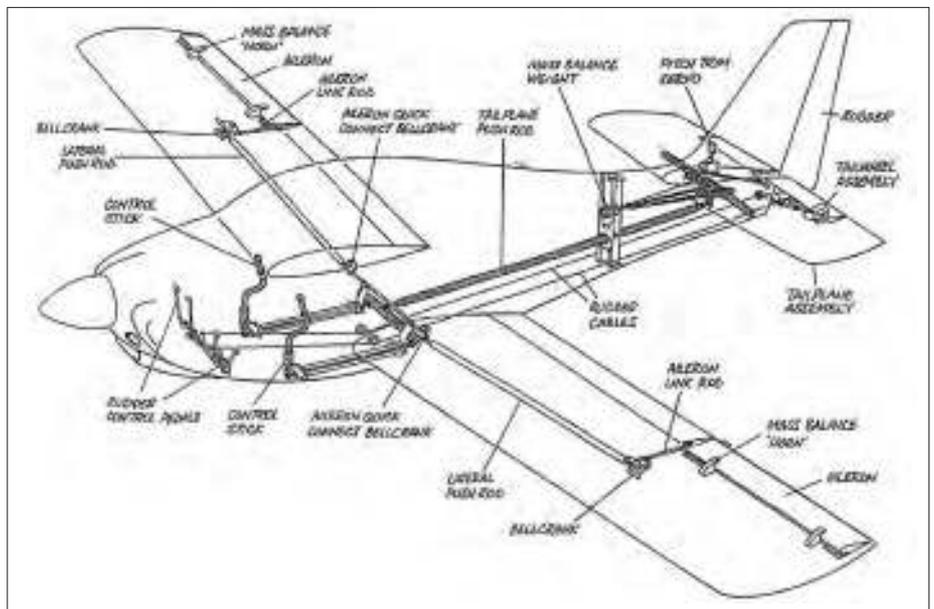
There are many reasons for corrosion; some of the specific reasons in this case, where a cable has been found in service in a very dangerous condition, is discussed in the text. This picture, showing the control 'runs' in the Europa aircraft, shows how difficult it can be to ensure that a cable is inspected fully throughout its whole length. Of course, corrosion and wear are much more likely at connections or where the cable direction changes around a fairlead or pulley, so these are the areas that need inspecting on an annual basis, but it is essential that your Tailored Maintenance Schedule includes, at the three or six yearly 'node', a complete inspection of the control cables. This inspection can, if possible, be done in-situ or, if this is not possible, the cables must be removed and the inspection carried out outside the airframe.
