With Malcolm McBride  
Airworthiness Engineer

# LOSSES, RESTRICTIONS AND FAILURES

A selection of incidents and accidents that demonstrate the importance of knowing and looking after your aircraft

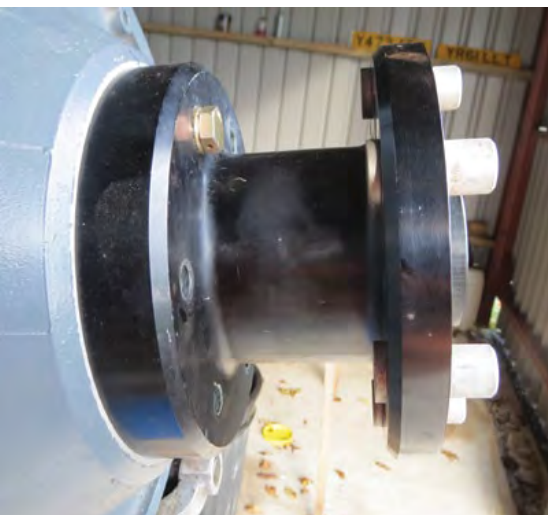
(Above) The propeller extension as fitted to Rob's RV-3 (to the left is the starter ring gear). The ferrules, colloquially called 'Top Hats', act as both a nut and to provide a positive location of the propeller.  
(Photo: Rob Hatwell)

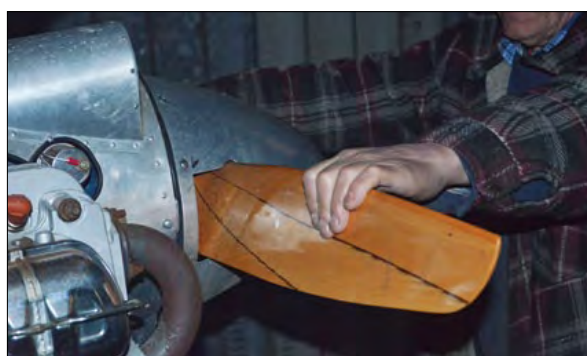
(Right) Newton Propellers is now owned and operated by keen LAA'er Alan Haseldine; here's a picture of him pulling his newly built Hummel Bird out of the hangar by the propeller as a demonstration to show how these leading edges might be becoming damaged. Alan tells me, "The leading edges are actually moulded using a liquid resin directly onto the propeller. Great care is taken to ensure that the recessed bonding face is absolutely clean and that temperatures and humidity values are within the bonding limits." If you own a propeller with a bonded leading edge, and there are a number of manufacturers using this system, if you absolutely must pull the aircraft by its propeller (never a very good idea, for several reasons), don't press on the leading edge as it might well cause a minute separation of the glue joint locally underneath. This could allow water to seep into the joint by capillary action, after which it will only be a matter of time before swelling of the wood leads to complete joint failure. (Photo: Alan Haseldine)
