# RECORDING AND AVOIDING ACCIDENTS

Among Malcolm's investigations this month is a visit to the AIB's accident investigation workshop and cases of canopy failure

### ZENAIR 601 (UL) – CANOPY FAILURE

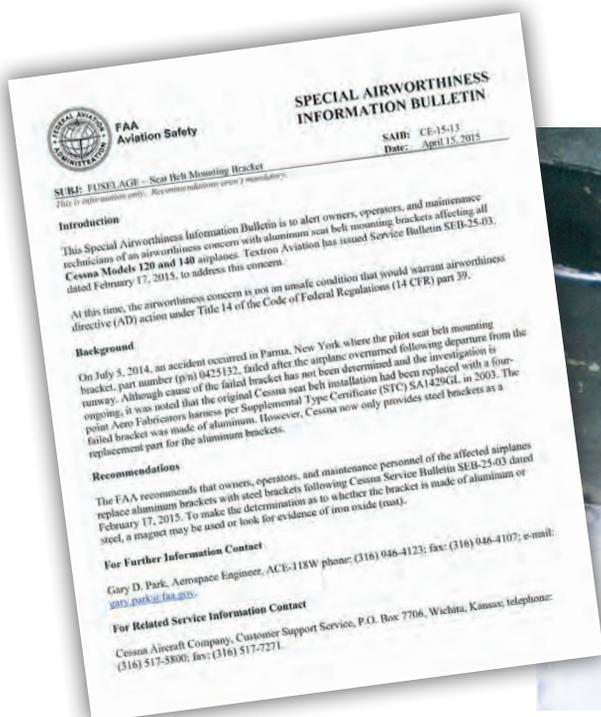
(Above) Readers of the April Safety Spot will remember the discussion surrounding the importance of regular inspections of seat belt anchorages. I made a bet that the FAA would issue an AD mandating the recent Cessna Service Bulletin about upgrading seat belt attachments on the 120 and 140 aircraft. I've lost the bet as the FAA has limited its response to a *Special Airworthiness Information Bulletin*. Check out the ALERTS page on the LAA's Website where a link to this document can be found. (Photo: FAA/Cessna Web Forum)

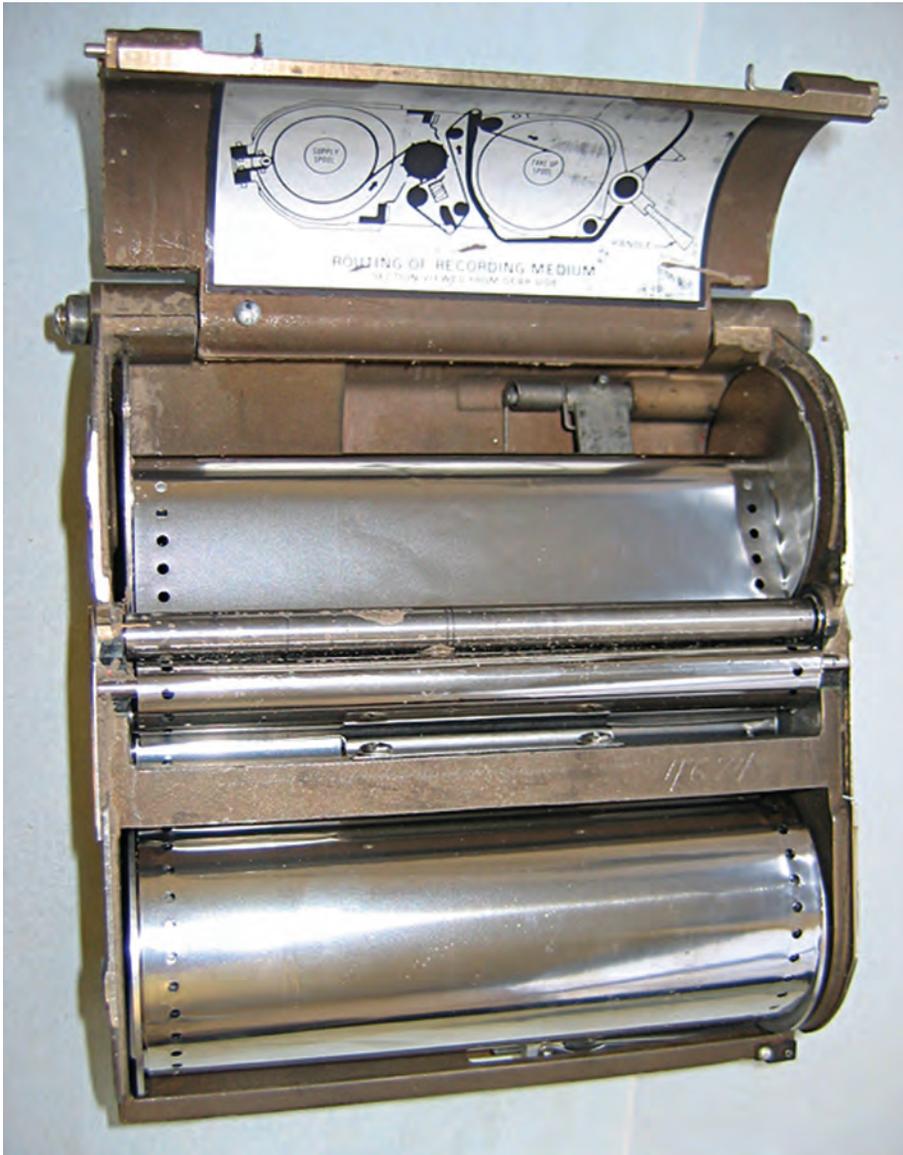
This is a quite early foil recorder. I expect that readers who took their Silver 'C' badges in the 1970's, as I did, will remember the barographs of the day which, apart from only having height and time as parameters, worked on similar principles. I seem to remember having to smoke the foil before fitment and, after a recordable flight, hair spray became an important element in ensuring a successful application. (Photo: Mark Ford AAIB)

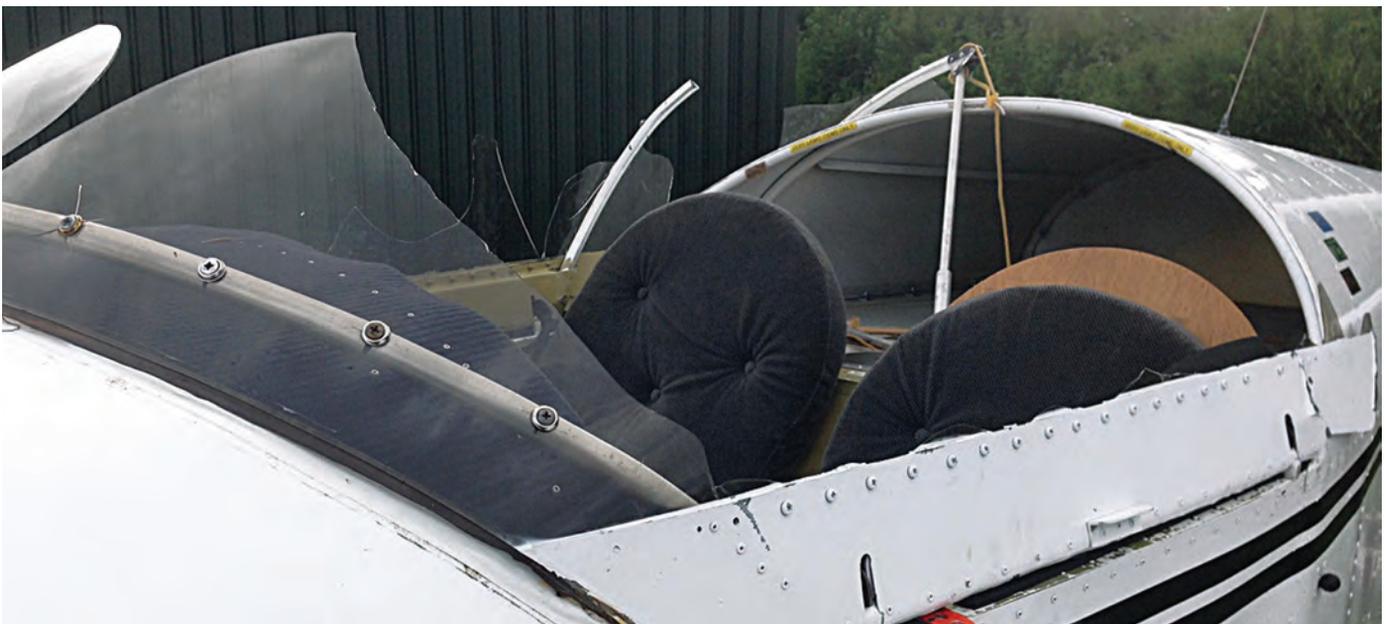
(Right) The canopy of the featured CH 601 UL aircraft after a canopy failure; I have underlined the a because, in truth, this picture was taken after a subsequent failure – it just goes to show that lightning can strike in the same place twice! In this second failure the cause was absolutely established as an incorrectly latched canopy before take-off. (Photo: LAA Library)

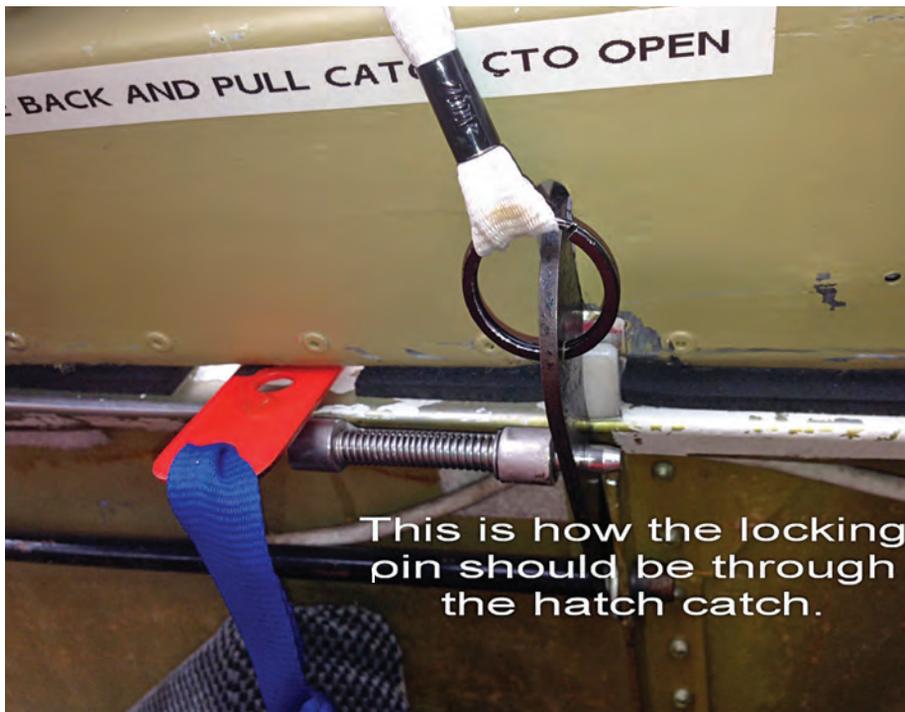
*(Above)* By far the main cause of in-flight canopy failures is that they're not secured correctly before flight – in this case the pilot sent us a picture of what he thought must have happened. Fortunately, no bones were broken. Normally, the last two items on a light aircraft pre-take-off checklist are Hatches – Secure, Harnesses – Tight. Just chanting the checklist doesn't work, you have to actually check to make sure the job's been done! *(Photo: LAA Library)*

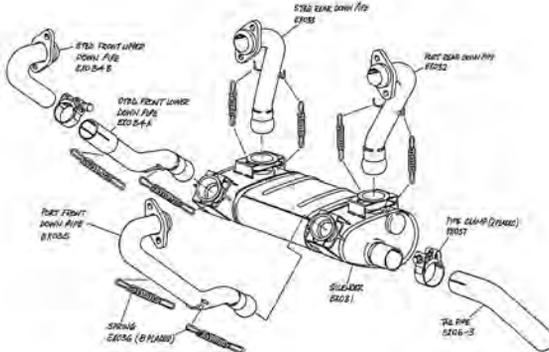
(Photo: David Cameron)

Thanks to Oban based LAA'er Donald Cameron for sending us this picture of the failed exhaust on his Europa XS. Donald explains, "Whilst on a flight earlier today, I was flying along and, all of a sudden, there was a sudden change in engine sound. No engine vibrations felt, it just got very noisy. Ts and Ps were within range and everything was performing as it should. I therefore presumed there was a problem with the exhaust system somewhere. Noting this wasn't normal, I performed a quick turn around and headed straight back towards my departure airfield."

You can see that this exhaust system, specially made by CKT Exhausts for the Europa, is actually quite a complicated piece of engineering. Naturally we've seen examples of exhaust cracking before, but I think that this sort of failure, after only 30 hours of running, is unusual. The failure appears to have emanated from the welded spring attachment tang and it's possible that the material has become thinned, or perhaps embrittled. I would imagine that the precursor crack would have been spotable some time before the complete failure and, perhaps, that's the lesson that should be drawn from this failure.

Whatever the cause of this particular failure turns out to be, hats-off to CKT who exchanged the damage part FOC without quibble.
