FOD FOR THOUGHT & WHEELS-UP LANDINGS

A new collection of cautionary tales that highlight importance of foreign object debris and faulty components. Would you know how to react if it happened to you?

Christen Eagle – Jammed Elevator Control

Spitfire Mk. 26 – Undercarriage Failure

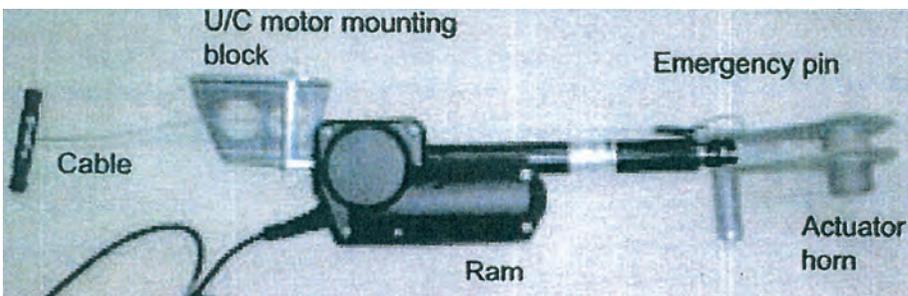
(Left) This picture, taken straight out of a Spitfire Assembly Manual, shows an undercarriage operating ram. As you will note, it's basically an electric motor driving a ram via a worm gear. Although worm gears provide a very good reverse-lock function, the Mk 26, which has a motor for each undercarriage leg, also has separate up and down locks. (Picture: Mk 26 gear motor)

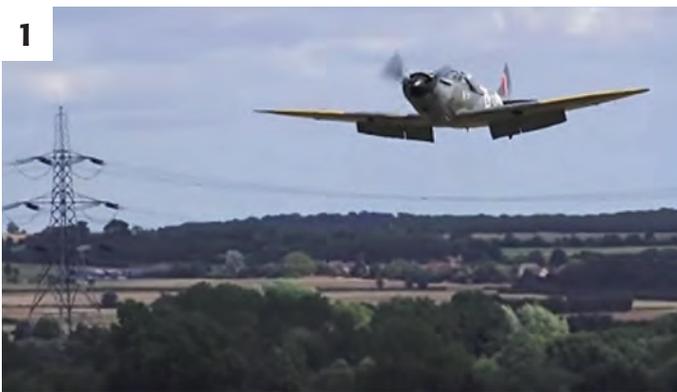
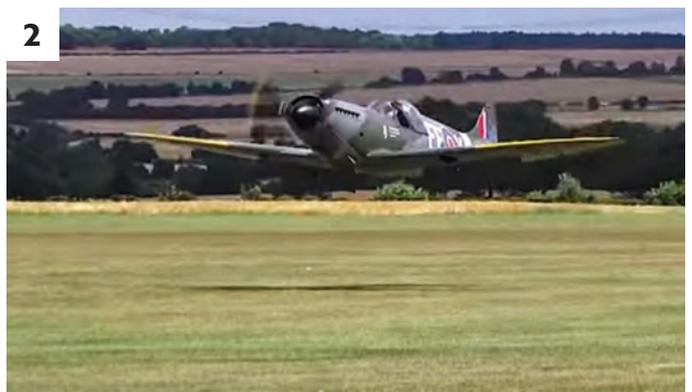
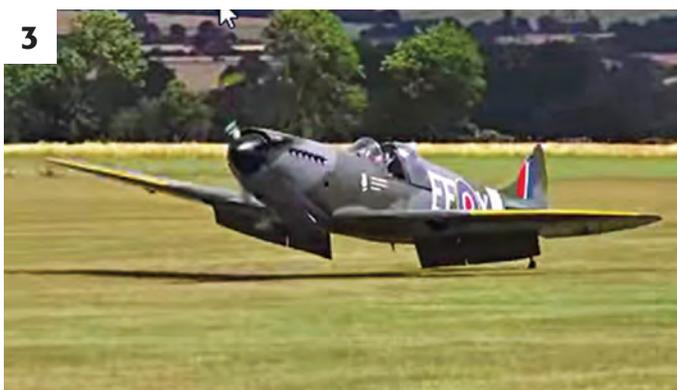
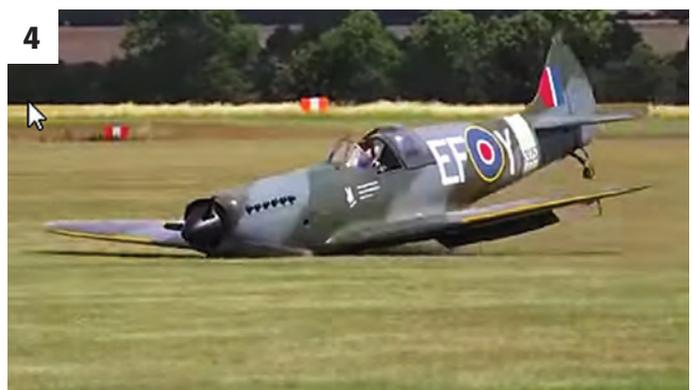
First of the phew! Many of you will have seen this video showing LAA Pilot Andrew Thomas landing his Mk 26 Spitfire wheels-up at Leicester Sibson airfield recently. I've mercilessly pinched these frame-by-frame images showing the sequence of events during the, well, arrival! The important thing about a situation like this is that the pilot walked away from the incident without a scratch, so well done to him for handling a very difficult situation in an exemplary manner.

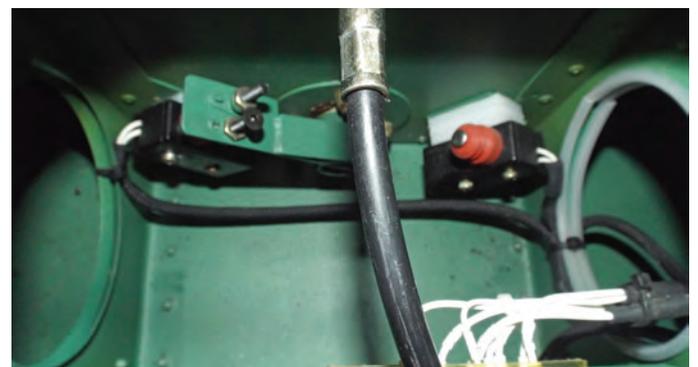
(Left) The operation of the undercarriage on the Mk 26 is reasonably complicated. This picture shows the left and right undercarriage operating levers – pulling the levers back, either one at a time or both together, releases the undercarriage lock-pin(s). When the levers are fully back, a microswitch completes the electrical circuit and the motor will function. When the undercarriage reaches its correct position, either up or down, a microswitch at the undercarriage leg sw-ew's aircraft – whilst the undercarriage was up, the system was being told that it was actually down! *(Photo Gary Cotterell)*
