With Malcolm McBride
Airworthiness Engineer

IS IT TIME TO CONSIDER A 'DEEP INSPECTION'?

Problems with iPads, but that's not the real theme this month. It's the underlying issues which call for an occasional major inspection

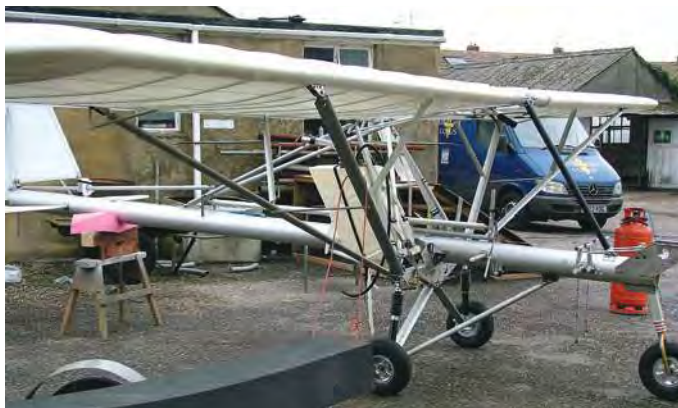
Here's a picture of the C42 during its build and before being fitted out with its full wardrobe; as you can see, the fuselage structure is centred around a beefy fore and aft. main boom. It looks like fun to fly just as it is! The area where cracking has been discovered on one high-hour BMAA training machine is the connection between the main fuselage boom and the leading edge wing strut. You can see that a complete failure of the connection at this point would lead to a sudden increase in angle of attack which could precipitate a total in-flight structure failure.

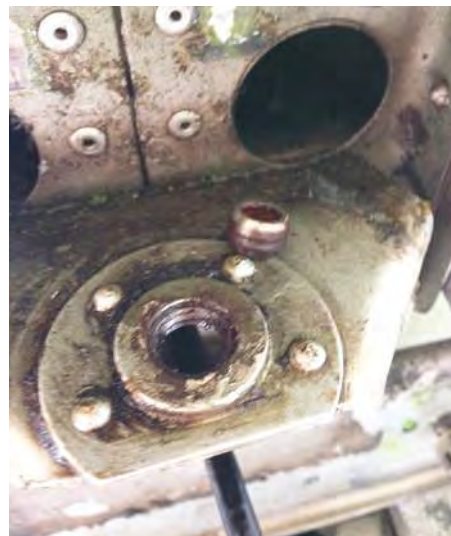
(Left) Here's a picture showing one tell-tale sign that all is not well with a riveted joint, notice the black powdery substance surrounding the third rivet up. This normally means that the rivet has become loose and therefore stopped working. This bracket, this time from the real tail attachment of a fairly high-time EV97, attaches the threaded steel plate holding the horizontal tail surfaces in place.
