With Malcolm McBride
Airworthiness Engineer

WET, WET, WET AND CAN WE LEARN FROM ACCIDENT STATS

Malcolm warns about the risks involved in storing an aircraft for a protracted period in damp conditions and considers the 2015 LAA accident statistics

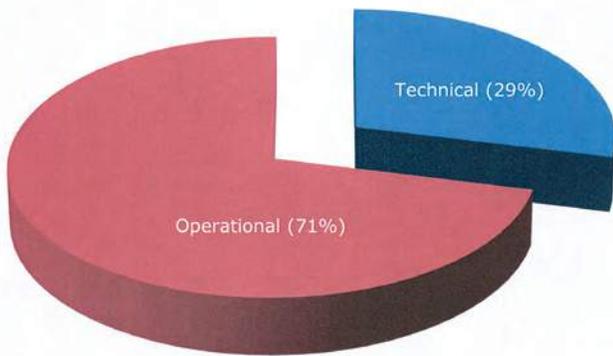
(Above) In 2015, from a total of 66 reportable incidents or accidents, 47 (71%) were primarily caused by operational reasons and 19 (29%) had, primarily, a technical cause. (Photo LAA Engineering)

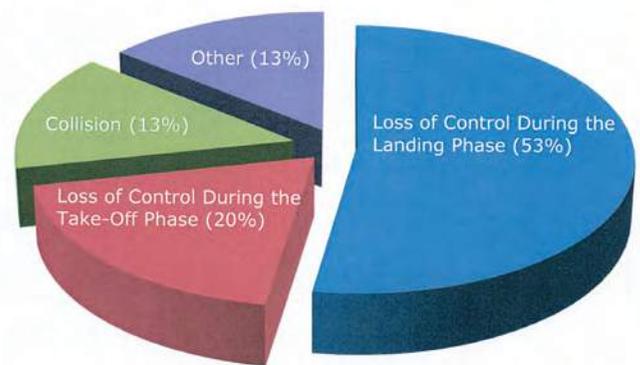
(Above right) As would be expected, loss of control, especially when close to the ground, accounted for the majority of our operational events last year. (Photo LAA Engineering)

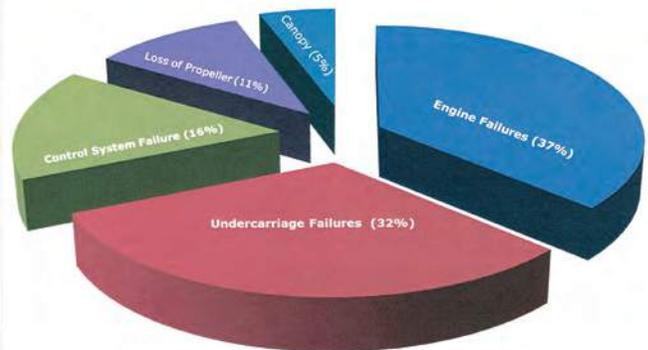
(Right) Engine failures and undercarriage problems account for nearly 70% of the reported 'technical' accidents through 2015; we lost two propellers and one canopy overboard, while control system failures included one throttle control failure and one uncommanded pitch trim operation. (Photo LAA Engineering)

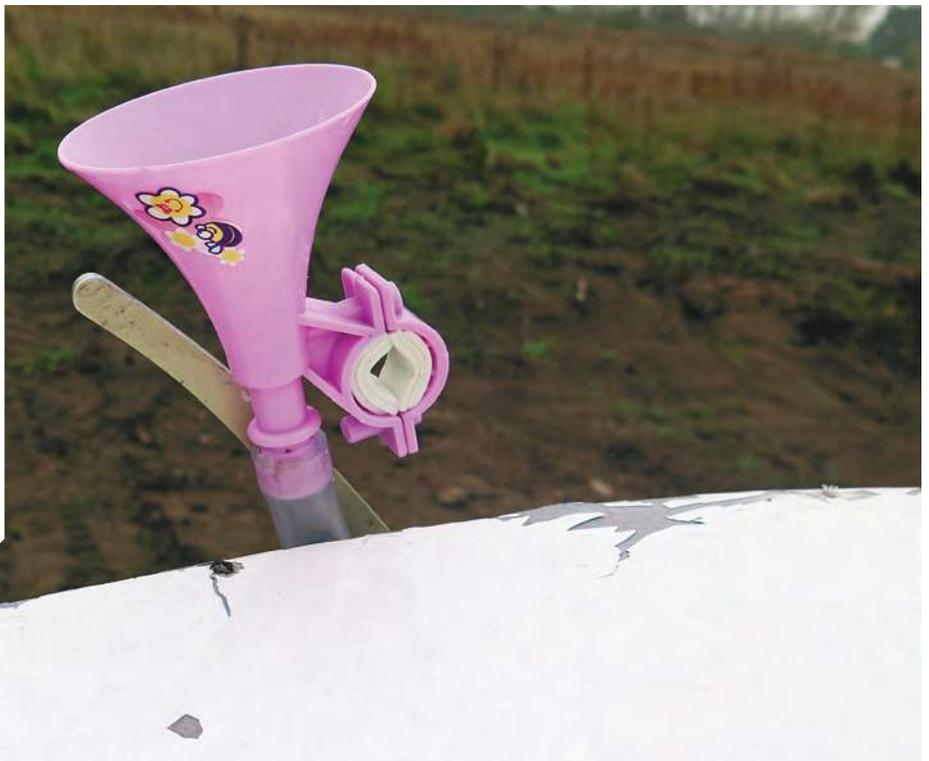
Can you guess what this is? The AAIB Investigator charged with the responsibility of working out how the accident had happened couldn't; well, when he first came across it, it wasn't actually attached to the airframe! The Jabiru has a very effective stall-warning system based upon the angle of attack of the wing; when the angle is nearing the stalling angle, an orifice in the leading edge of the wing senses low pressure, sucking air through a neoprene tube connected to a horn. Sucking air through the horn gives an audible warning to the crew, alerting them of the dangerously high angle of attack. The builder of this aircraft decided to use part of a child's trumpet as the horn, rather than the horn supplied in the kit; bet you wouldn't find one of these on a triple seven!
