With Malcolm McBride
Airworthiness Engineer

DE HAVILLAND DH82A TIGER MOTH – IN-FLIGHT BREAK UP

MINICAB (JB01 STANDARD) – PROPELLER STRIKE ON START-UP

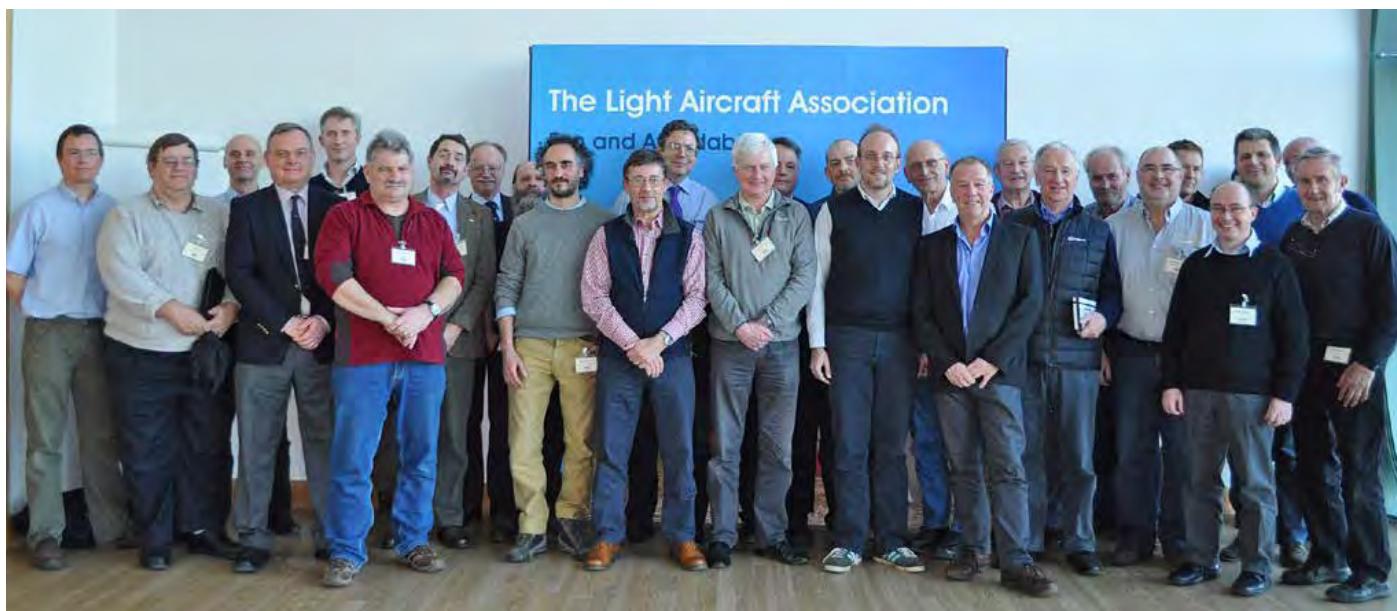
'If the devil were to cast his net' ... he wouldn't find any victims in this crowd! Well, hopefully anyway. This is the line-up of the delegates who attended the recent Agents' Seminar ... missing quite a few notables who rushed off at the end so that they could remain day VFR for their flights home. The object of the day was to better explain the process of bringing a new aircraft type onto the LAA's books and to offer a space for a discussion forum where better ways to make this complex process operate were discussed. We think the day was a success and the LAA intends to put on more seminars in the future.
