JABIRU 2200 ENGINE – STARTER RING ATTACHMENT

Safety Spot

MK.26 SPITFIRE – UNDERCARRIAGE RETRACTION ISSUES

EUROFOX – UNDERCARRIAGE FAILURE

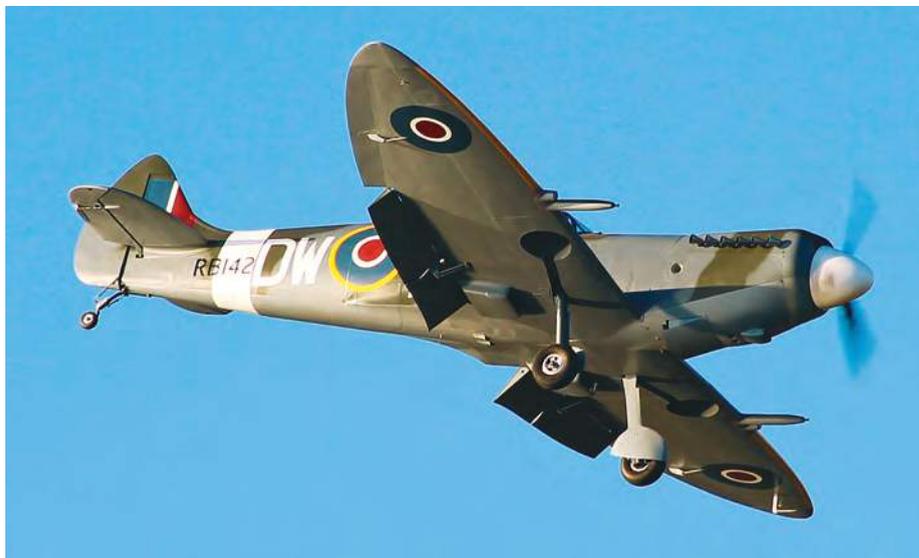
(Above) I couldn't resist putting this picture of LAAer Dave Bishop's Kit Built Mk.26 Spitfire. You can see that the aircraft is on its approach to land, flaps and gear fully down. Dave has yet to fly the aircraft solo and his attempts to do so have been rather thwarted by technical issues post-build. The most recent problem involved bent undercarriage legs, caused during a 'gentle' ground-loop, is discussed in the accompanying text.
