With Malcolm McBride
Airworthiness Engineer

FUEL PUMPS, CARB RUBBERS AND FILTERS

Disparate issues this month, though they are all related to the tricky subject of inspections and maintenance

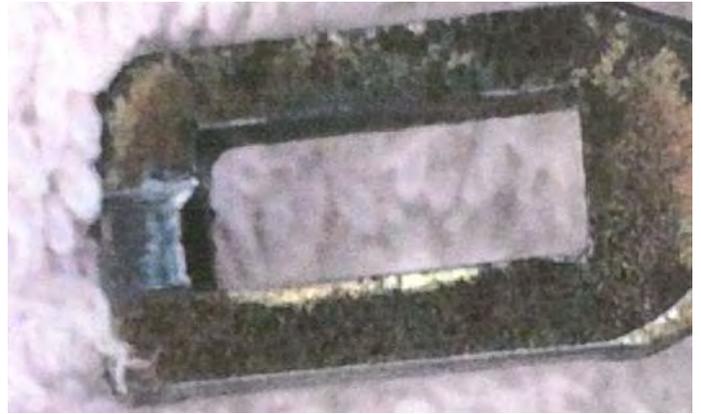
(Right) LAA flyer Graham Elvis sent us an excellent report into the causes of a serious loss of power incident he suffered in a Rans S6 back in 2015. In the end he established that the problem was a malfunctioning fuel pump... another unusual failure mode. In this case the rocker arm 'jumped' out of the slot in the diaphragm pull-rod leaving this tell-tale witness mark. (Photo Graham Elvis)

happily at 2600rpm but at 2900rpm (flat out) it would lose power after about 10 seconds. It ran perfectly with the fuel pump bypassed (gravity only) so the pump contributed significant resistance to the flow in its failed state."

Naturally the non-functioning pump was changed, fuel flow checks carried out and the aircraft returned to service. Graham commented that when he examined the failed pump he found a number of things he wasn't happy with, notably the screws holding the two halves of the pump together were barely tight – 'finger-tip on a screwdriver' – though no fuel was leaking from the joint.

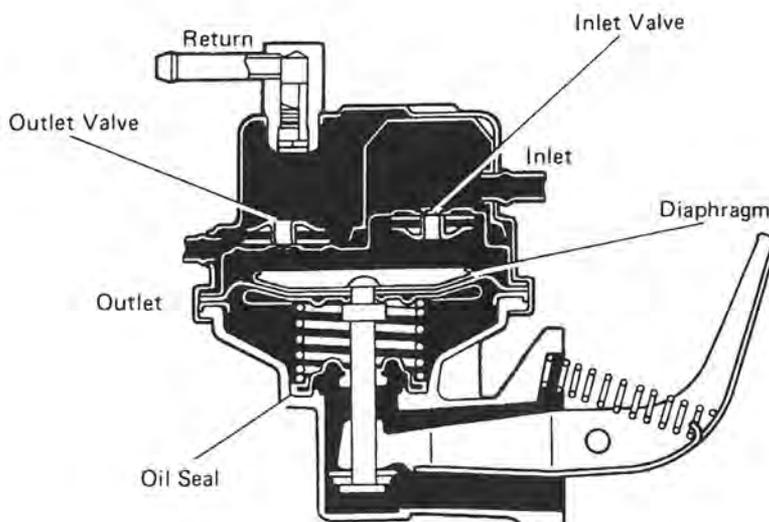
A couple of days later Dave rang and explained what had gone wrong. It seems that the root cause of the problem was that the hook that attaches the pump's drive arm to the diaphragm pull-rod had broken off, rendering the pump inoperative. Fortunately, the aircraft is equipped with an electrical back-up fuel pump for this eventuality, though this had also stopped working.

(Above) Here's a close-up showing the failed AC pump's inner arm/diaphragm failure; the broken end of the rocker-arm hasn't yet been found. (Photo Dave Bonsall)

Dave, naturally, replaced both pumps >
