# SAFETY SPOT: LESSONS LEARNT FROM OTHERS' MISTAKES

## Another 'runaway' after a hand start – a costly blunder

### DHC-1 CHIPMUNK – RUNAWAY AFTER ENGINE START

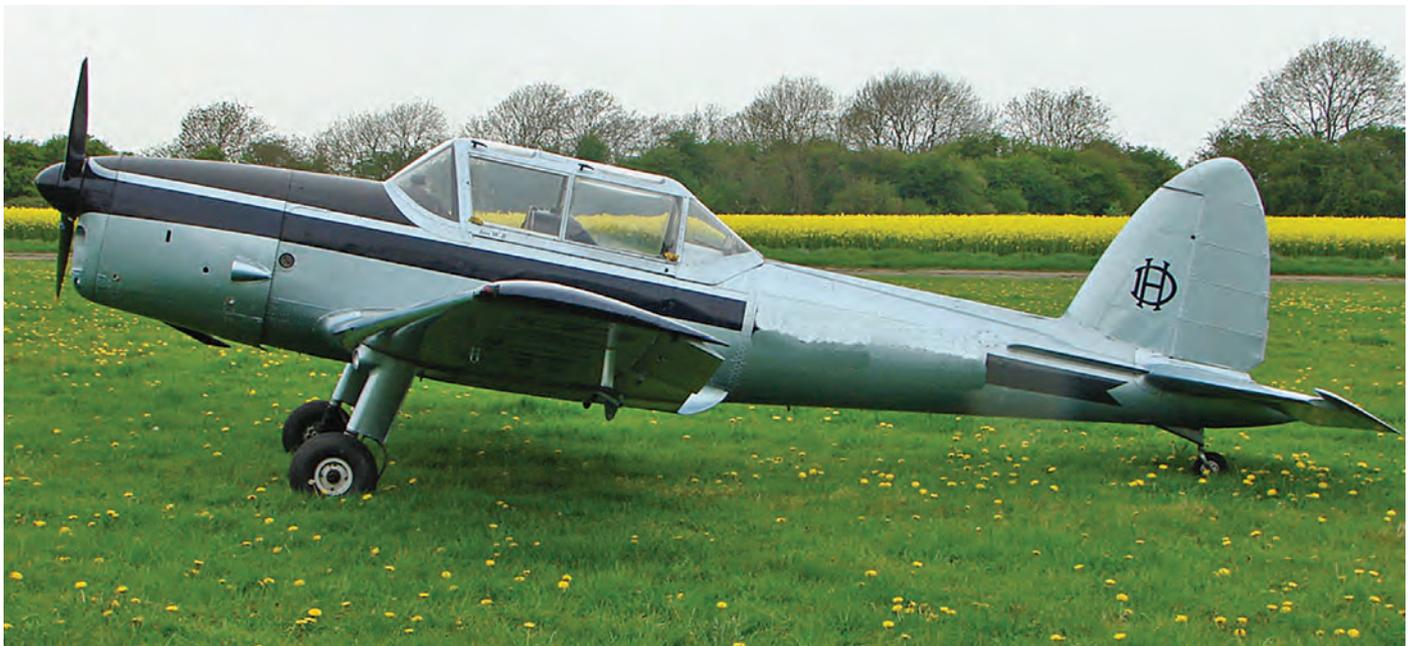
(Above) This lovely example of a DHC-1 Chipmunk 22 has only recently joined the LAA fleet. It was first registered in the UK in 2004, having been built under licence in Portugal in 1958. The aircraft is (effectively) a Mk.10, badged as a Mk.20 (as an 'overseas' build) then re-badged as a 'civilianised' Mk. 22. I thought that the DHC-1 was the first post-war de Havilland design to go into production, but was reminded by Bill Taylor of de Havilland Support that, though ground-breaking in design, the de Havilland Dove takes this honour. Don't be fooled by its simple appearance, the 'Chippy' is still a complex ex-military design requiring specialist care... especially as many of the examples still flying are entering their seventh decade.. (Photo: G-INFO)
