Safety Spot
By Malcolm McBride

ROTAX PUSHRODS ALERT, SPORTCRUISER NOSE LEG ISSUE, TWISTER AIR SHOW ENGINE FAIL & PLACARDS

The latest LAA Engineering topics and investigations

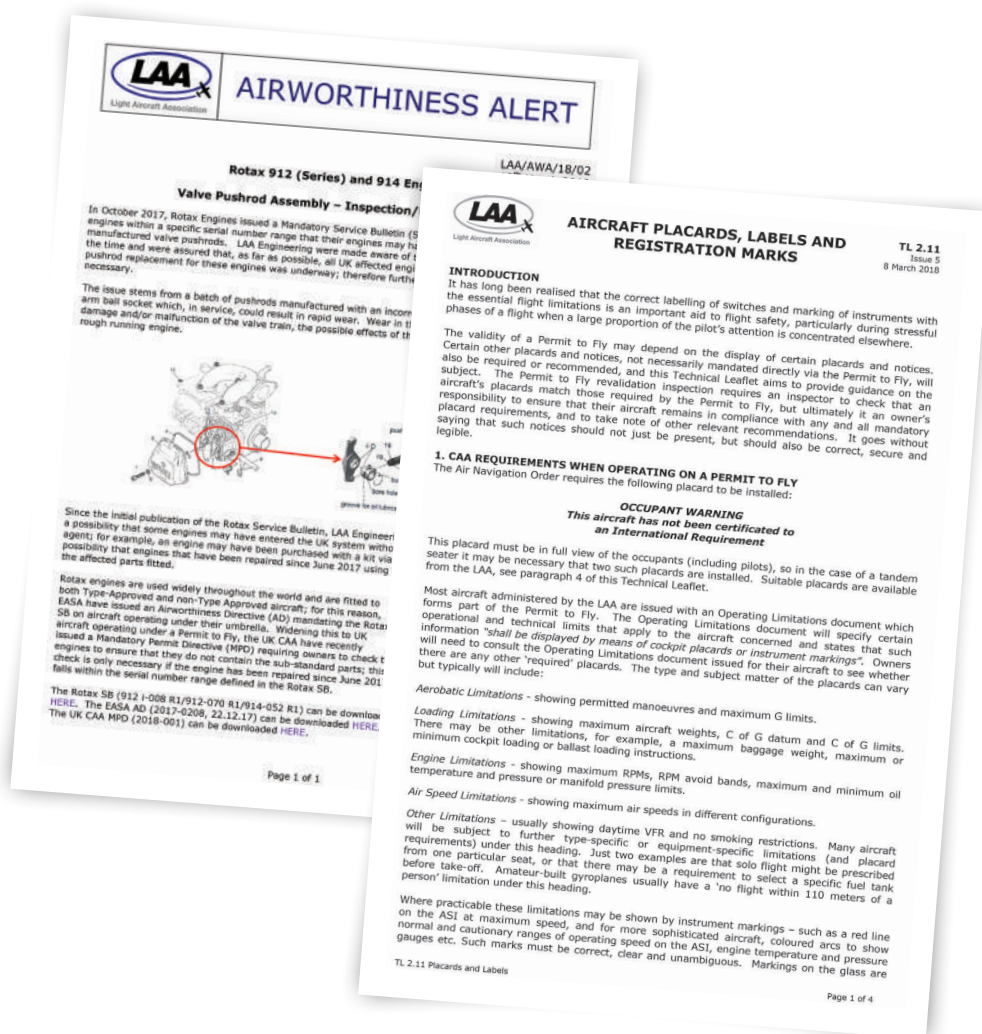
You will see from the pictures above right that LAA Engineering has issued an *Airworthiness Alert* (LAA/AWA/18/02) and 'up-issued' the existing *Technical Leaflet TL.2.11*. As the associated pictures show, the *Alert* is about a quality-related issue concerning some pushrods fitted to both the Rotax 912 and 914 Series engines assembled or repaired since June 2017.

In this case, the hardening process on the rocker arm ball socket – that's the contact point between the rod itself and the rocker arm – went wrong and, in service, the sub-standard parts suffered accelerated wear. Though this isn't something that's likely to cause a catastrophe in the short term, wear will affect the operation of the engine's intake and exhaust valves and could, over time, lead to a gradual power loss. Eventually, of course, this ball-end could give way completely and that would very likely stop the engine.

(Above) LAA Engineering has recently published two documents, both in response to external safety recommendations by other stakeholders. The first, an *Airworthiness Alert*, offers access to a recent *Mandatory Permit Directive (MPD)* requiring owners of Rotax 912/914 engines to check their paperwork to see if their powerplants might contain a set (or sets) of defective valve pushrods. The second is a rewrite of a *Technical Leaflet*, giving guidance on the correct placards needed on our aircraft to stay safe. Both documents can be found in the Engineering section of our website. (Photo: LAA Library)

purchased from an overseas source may have defective rods so, to be safe, check its serial number against the list in the *Rotax Service Bulletin* – there's a link in the *Alert*.

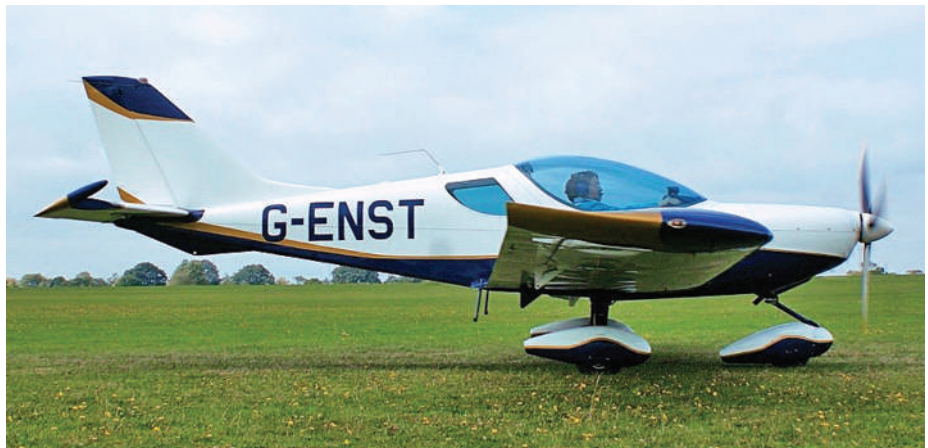
(Above) I had a choice as to whether I used this 'stock' photo of the group-owned CZAW SportCruiser which was recently involved in a nose undercarriage leg failure, or a picture of the aircraft sat at a rather ungainly angle, sent in by the unhappy pilot after the incident. On reflection, I'm glad I chose this shot as it shows the clean lines of this fabulous, two-seat, kit-built machine rather better than the one with its tail up! Note that this aircraft has very close-fitting spats, which although they look good and offer some drag reduction, are bad for keeping a close eye on the undercarriage system. (Photo: Martin Uzzell)

The occurrence itself was a fairly benign event because the leg failure occurred while the aircraft was taxiing at quite a low speed. Consequently, the damage was limited to the propeller which, naturally, disintegrated when it hit the taxiway's concrete surface.
