Safety Spot  
By Malcolm McBride

# GROPPO/SAUER FUEL AND IGNITION FAIL, THE MORANE SAULNIER ON THE SHORE & ROTAX FUEL PRESSURE ISSUE

The latest LAA Engineering topics and investigations

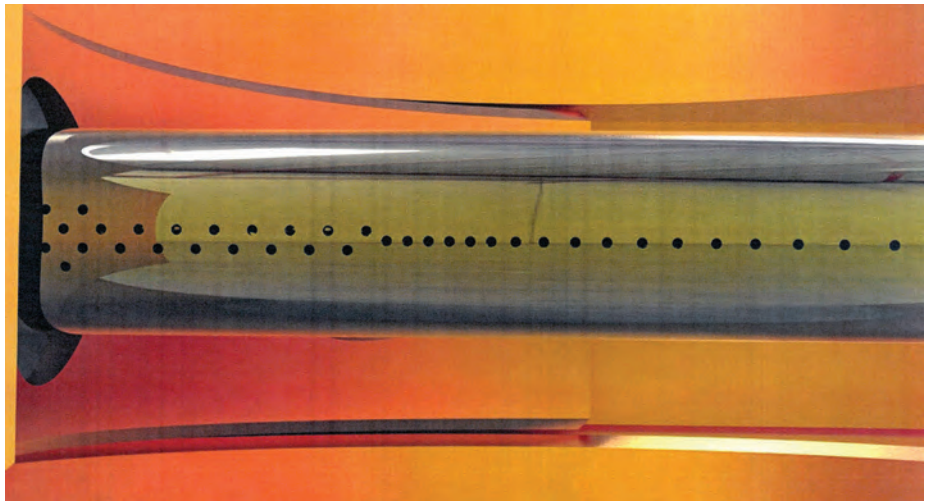
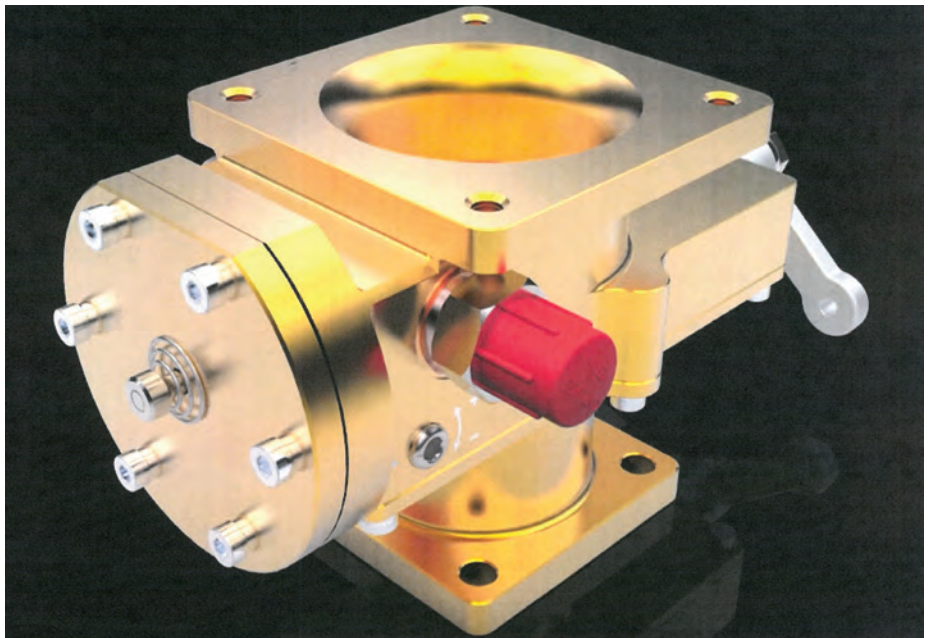
*(Above)* The mystery of the excessive fuel use on the Rotec R3600 Radial engine solved – the loss of a simple spring connection meant that the primer button remained in the ‘priming’ position, even though the cockpit control lever had been returned to the primer shut position.

Clearly, a minor design modification was required, so that if a control cable or spring failure occurs the system will fail in safe-mode – in other words, primer off. With the primer button closed, the fuel pressure regulator is effectively disabled, and it’s been estimated that the engine could use up to four times as much fuel in this condition. *(Photo: Zac Rockey)*

(Top & above) Originally, Rotec Radial engines used a standard Bing carburettor. However, after trying the Ellison Throttle Body Injector (TBI) system on one of their models, and noticing an immediate improvement in performance, Rotec decided to design a TBI of its own. Don't confuse a TBI system with conventional injection, it's more akin to a carburettor, in that the TBI introduces fuel to the engine via a centre-mounted spray bar (shown at top), rather than directly (or indirectly) into the cylinder via a metering unit. The early Rotec units had a remote fuel pressure regulator, which controls fuel quantity, but the newer units (shown above) place the fuel regulator on the side of the TBI itself. Note the 'priming' button, far left, in the centre of the regulator's diaphragm housing. (Photos: Rotec Engineering)
