Safety Spot  
By Malcolm McBride

# INSPECTION-TRIGGERING INCIDENTS, A COLLAPSING TITCH, HIDDEN DAMAGE & A TALE OF TWO REBELS...

The latest LAA Engineering topics and investigations

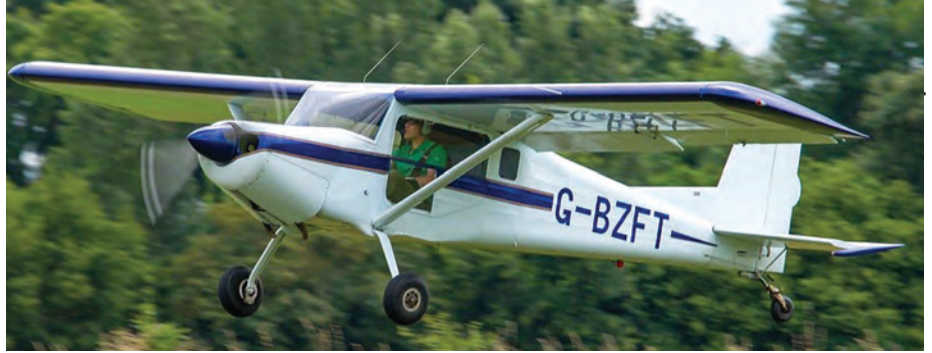
(Above) The Murphy Rebel is a two-seat, high-wing, all-metal monoplane which is available in kit form for amateur construction from Murphy Aviation Ltd, British Columbia, Canada. The Rebel is of conventional, riveted 6061-T6 sheet aluminium alloy, semi-monocoque construction and has a reputation for being a good short-field performer. A number of engine options are available – this example, one of the aircraft discussed in the main feature, is powered by the ubiquitous Lycoming O-320. The LAA has a total of 24 of these aircraft on our books, eight currently flying and ten of which are still under construction. (Photo: Tom Cole)

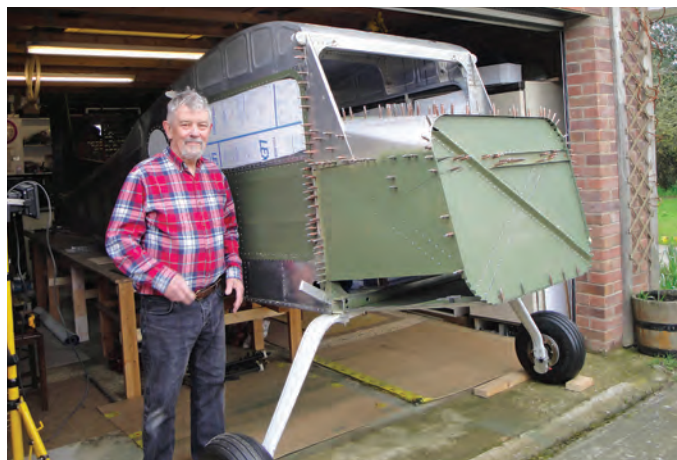
(Left) Owner Pete Hyde and his Rebel – he tells me that he’s made quite a bit of progress since this picture was taken. Pete began the build in the late-nineties, although what might be described as the ‘normal turbulence’ of life has meant a rather protracted project timeline.
