Safety Spot  
By Malcolm McBride

# SPORTCRUISER NOSELEGS, GROPPO TRAIL WING-BOLT LIFE & RV-9/RV-10, CH 601 UL AND EV-97 TAILPLANES

The latest LAA Engineering topics and investigations

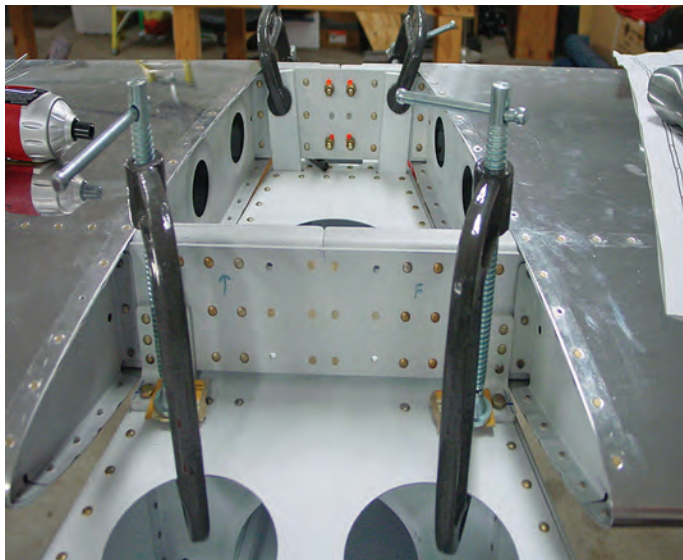
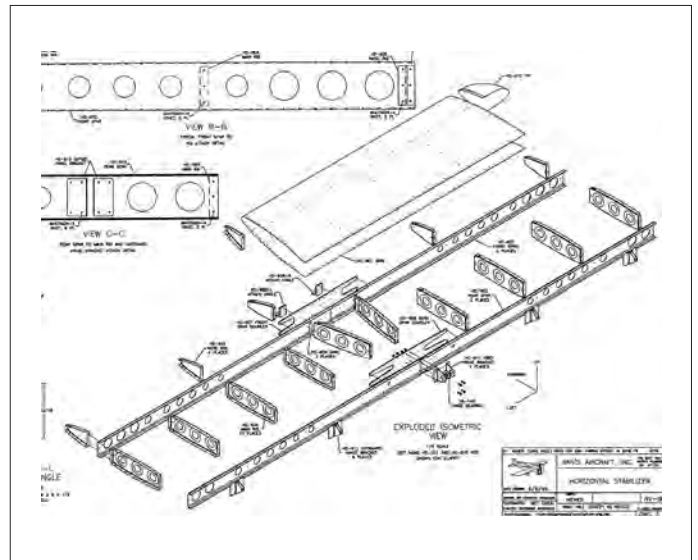
*(Above & above right)* These pictures of the centre section of a Van's RV-9 should orientate you still further. This time you're looking at the centre-section of a tailplane during its construction – though the clamps are rather in the way I hope you can see the two tailplane attachment brackets riveted to the tailplane's main spar. *(Photo/image: US Builder 'Josh/Vans Aircraft)*
