Safety Spot  
By Malcolm McBride

# SEASONAL CHANGES, CUB RUDDERS, SENSENICH HUBS, EUROFOX TUG PEDALS & ROTAX VALVE PUSHRODS

## The latest LAA Engineering topics and investigations

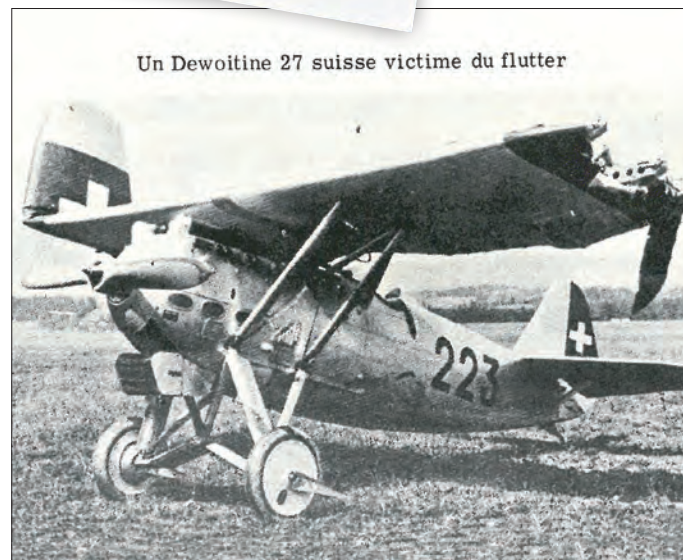
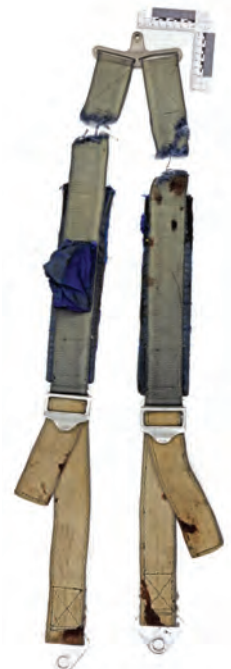
(Above & above right) Two of the *Alerts* cover non-aircraft specific topics and the first, *Safety Harness Integrity*, is a joint CAA/LAA initiative designed to bring the issues surrounding the quality management of the many different types of safety harness fitted to *Permit to Fly* types to the surface. This initiative was mounted in response to a recommendation from the Air Accident Investigation Branch (AAIB), following an incident where one pilot died and the other was seriously injured after seat belts failed during a forced landing.

The second *Alert* concerns the effects of seasonal change on both airframes and aircraft performance, and was driven by field reports from LAA Inspectors about slacking control cables and loosening propellers. The picture above, copied from an old RSA mag from the LAA's growing Library, shows a 'victime du flutter' – possibly the result of flying with slack control cables. (Photos: RSA/Courtesy of UK AAIB)
