# Safety Spot

Airworthiness Information Leaflets, corrosion and Chobert rivets

### Auster AOP.9 – Aileron Pushrod Failure

### Luscombe Tailplanes – Corrosion Inspection Update

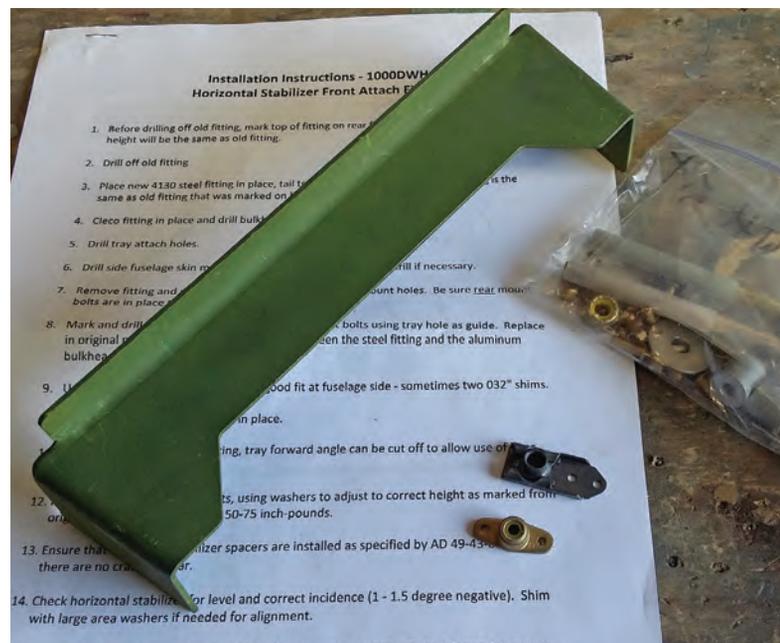
Regular readers will know that in the February edition of Safety Spot we featured a very scary story concerning unseen corrosion in the tail sections of a Luscombe. LAA member, and Luscombe restorer, Peter Bentley sent in pictures of some of the problems he encountered

during the refurbishment of the empennage on his aircraft. Peter worked alongside Luscombe specialist, LAA Inspector Owen Watts, and ended up pretty much renewing the whole tailplane such were the depths of the problems. One really scary picture, certainly the picture that created the biggest response from members, showed some very badly corroded tailplane attachment brackets.
