Safety Spot

Malcolm McBride considers issues concerning Jodel DR100 series seat frame fracture problems and Alpi pioneer primary control attachment points

Jodel DR-100 (Series) – Front Seat Failure

Alpi Pioneer Aircraft (All Marks) Security of Primary Control Attachment Points G-LLOY Elevator Stop / Pioneer Centre Elevator Hinge

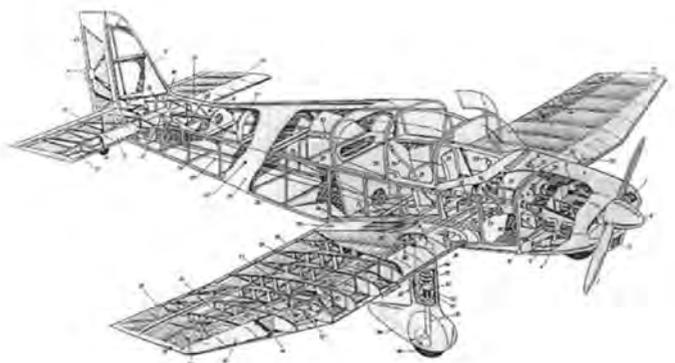
Above I couldn’t resist sharing his beautiful cut-away drawing. As you can see, it shows a Jodel DR 1050-M 2+2. You will notice that all three/four seat Jodel aircraft (DR-100 series) aircraft have adjustable front seats and, over the years, cracking has been seen in the tubular structure. **Credit: Frank Rogers**
