The latest LAA Engineering topics and investigations. By Malcolm McBride

Safety Spot

Malcolm discusses Stampe propeller failures, Jabiru control surface hinges and airspeed indicator problems

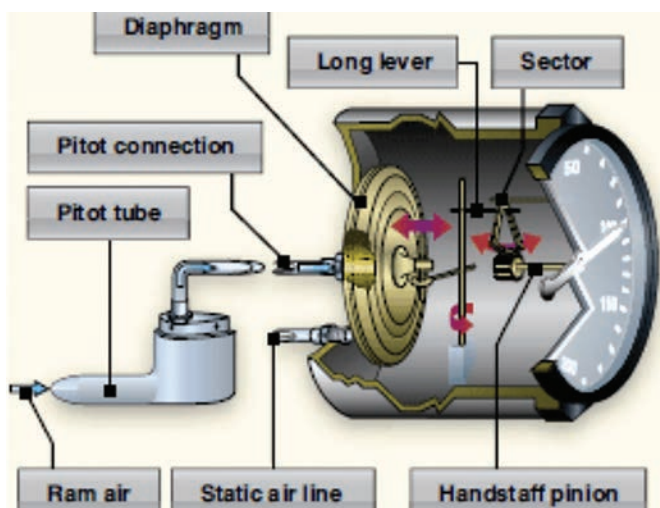
Above Three pictures to go with the two stories about problems with incorrectly reading ASIs. The first shows a simplified sketch of the mechanism inside a mechanical ASI; though they're precision instruments, in their simplest form their mode of operation is pretty straightforward. When flying sports aircraft of any class, the ASI is the most important measuring device on the instrument panel if you're going to keep safe, especially during the approach and landing phase. The picture in the middle is Bill's Christmas quiz picture and the one on the right shows why Mike had problems! **Photos: StudyFlying.com/Bill Brooks/Mike Williamson**
