CHECK, CHECK AND CHECK AGAIN

An insight into the day-to-day operations of LAA inspectors, both in the office and in the air, plus Jabiru failures update.

Jabiru control failures update

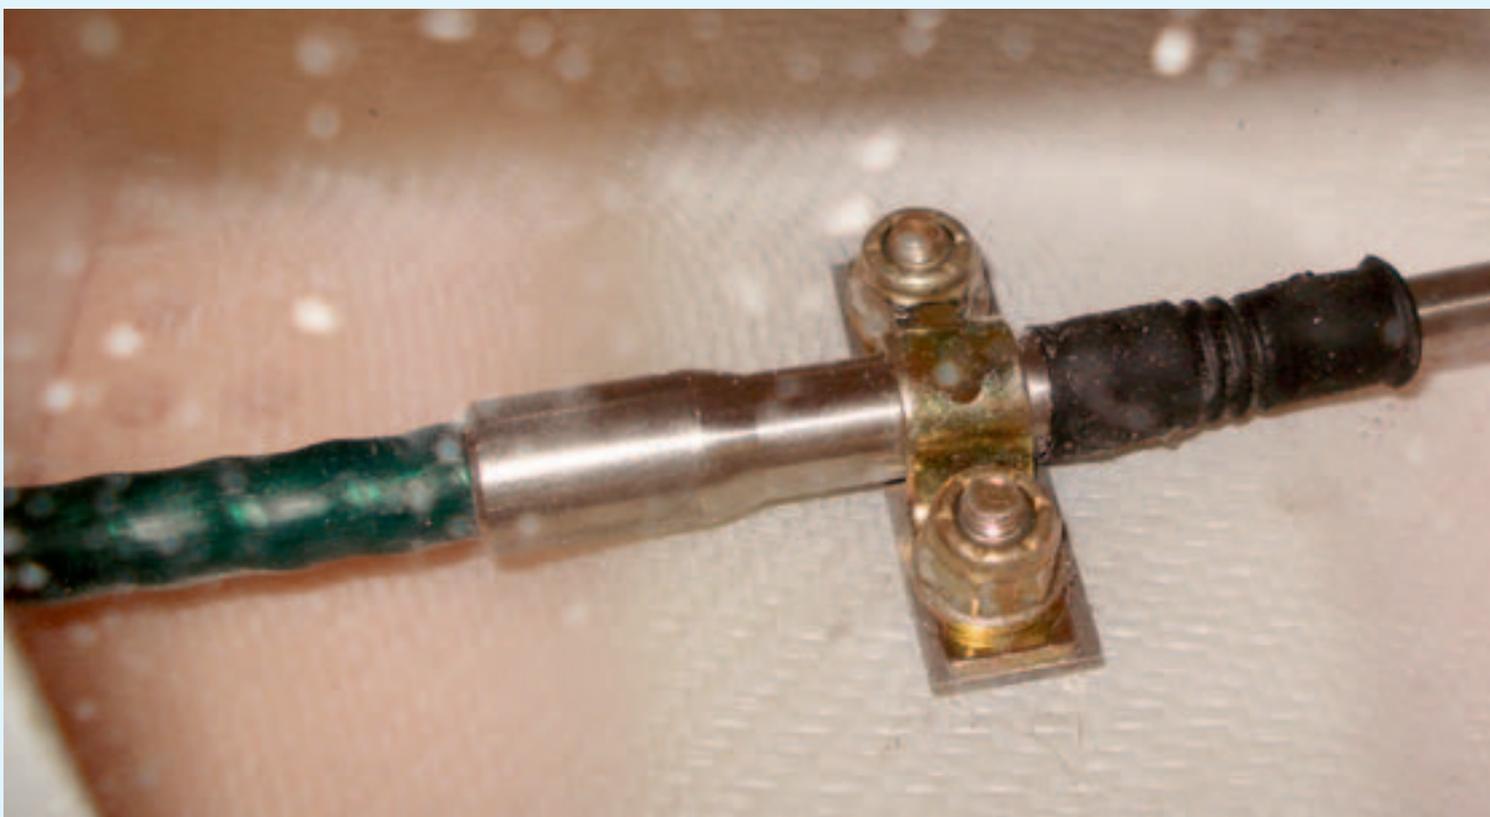
Clamps incorrectly assembled, the locking 'tang's' are misaligned and the clamp is not fitting properly around the body of cable
