# SAFETY SPOT

## Stresses and strains

## Wrong bolt leads to gear failure

## Where's the propeller?

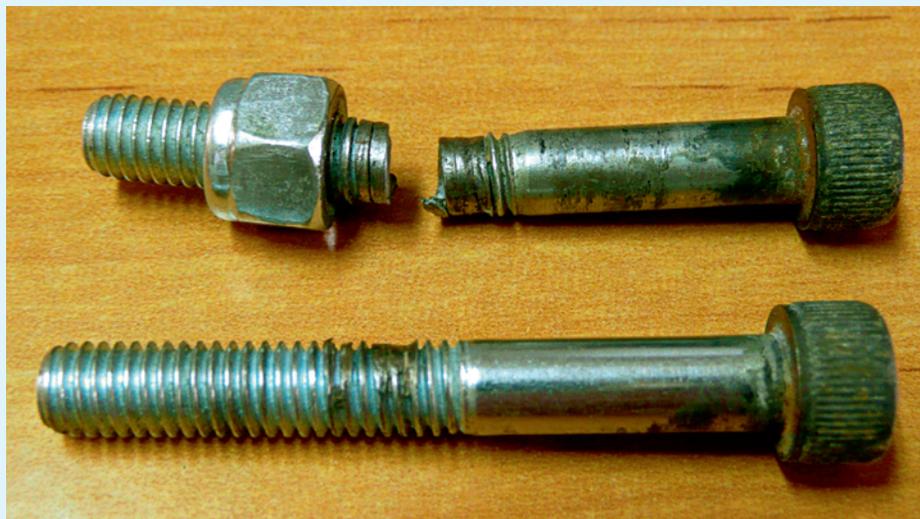
In his report he says, "On closer inspection of the (undercarriage) bolt it was found that the inner part was loose inside the fuselage. It had failed in bending and shear across the threaded portion of the bolt where the main loads had been applied."

Gerry goes on to say that the other undercarriage bolt was bent, "showing signs of imminent failure."

What it looks like has happened is that the appropriate aircraft-quality bolts have been substituted for commercial-quality cap head bolts of the wrong size.

The point of all this is that all bolts are not the same and before you even think about changing a bolt for a different type, check it out with the designer of the aircraft.

And, if you don't know him or her, don't change the bolt type.

it is not a good idea to 'up' the bolt specification. You might think that you're improving the assembly but, in fact, you could be inadvertently sowing the seeds of disaster.

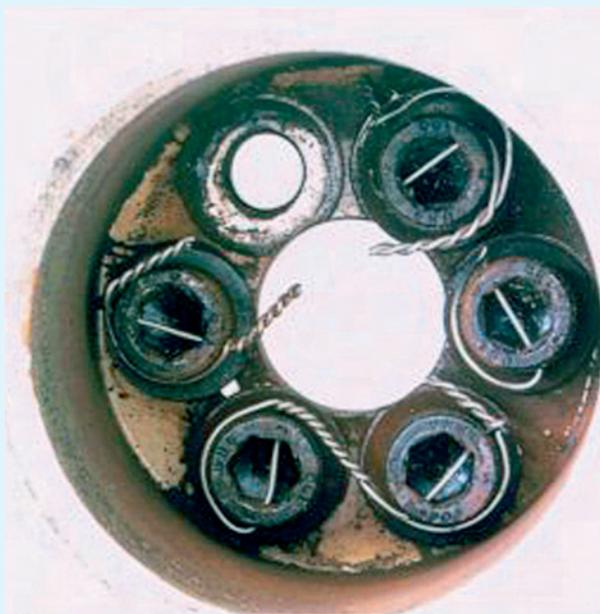
Impossible to see with the propeller fitted, but the wire locking has broken allowing progressive slackening of the bolts, leading to failure.

the flange to the engine. It appeared all the bolts failed, pretty much, together, although evidence from the recovered flange suggested that one of the bolts held on in one last gasp effort.

The conclusion of the tests suggested that the bolts' failure had resulted from some long-term, high-cycle fatigue mechanism fracturing the six bolts attaching the propeller flange.

Mr Tyrer's report said, "It is also considered that long-term progressive slackening of the six bolts resulted from frottage of the bolts in their relative holes and that this had been exacerbated by the use of bolts that had been threaded along their full shank lengths."

Take a look at the picture of the wire locking, easy to see now, but impossible with the propeller fitted. So, wrong bolts, wrong torque, broken wire locking and, last but not least, lack of inspection.

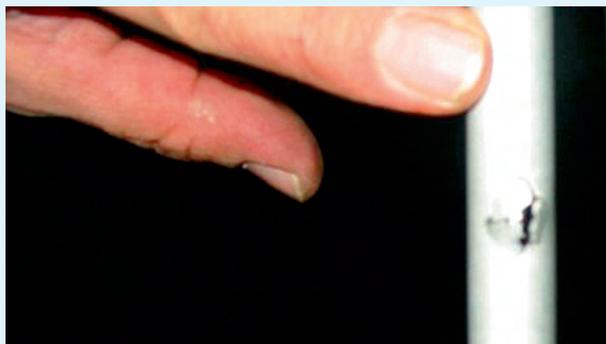
ONE of our newer inspectors, Steve Clarehugh, has reported a weird bit of localised airframe tube cracking he found while re-covering a Rans S6. To be honest, we're all a little foxed by this strange damage so we're thinking of getting the part analysed by a metallurgist.

Take a look at the picture. It's a first for me. Steve seems to think it may have been caused by ice forming in the tube.

Frame tube crack on a Rans S6 - was it caused by ice forming within the tube, or something else?

While we're on the subject of Rans aircraft, we have had a few more reported tailplane tube cracks. Keep your eyes open for cracking on these early microlight types.

Dave Almej, who has been a PFA/LAA inspector for over 25 years, called me last week to ask me to warn you all that cracking can happen anywhere. He has found cracks on the tailplane tube's rear attachment as well as the front - so be vigilant. Fair winds.
